PDAE CONVENTION 2009

**Results of Surface Preparation
Demonstration**

Dominique Smits

Group Product Manager, De Neef Conchem

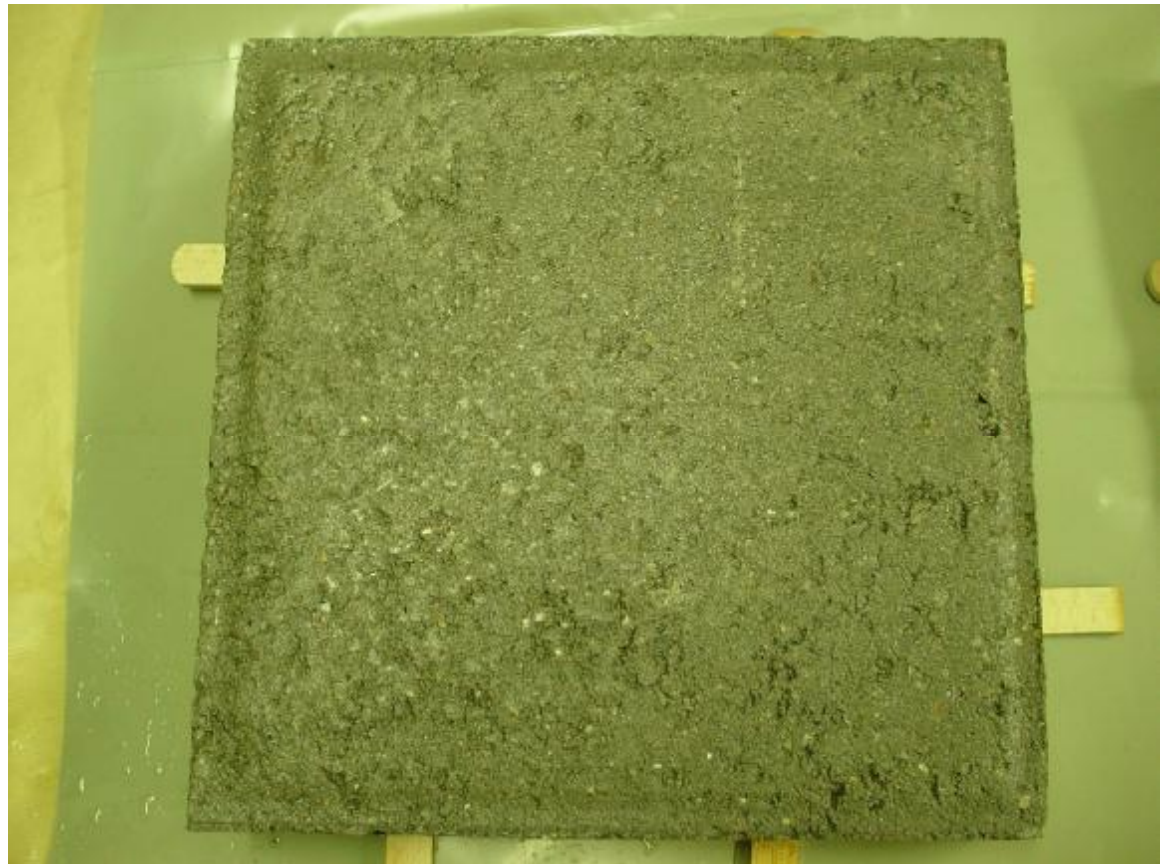
1. Spraying on a wet surface

Wet concrete surface

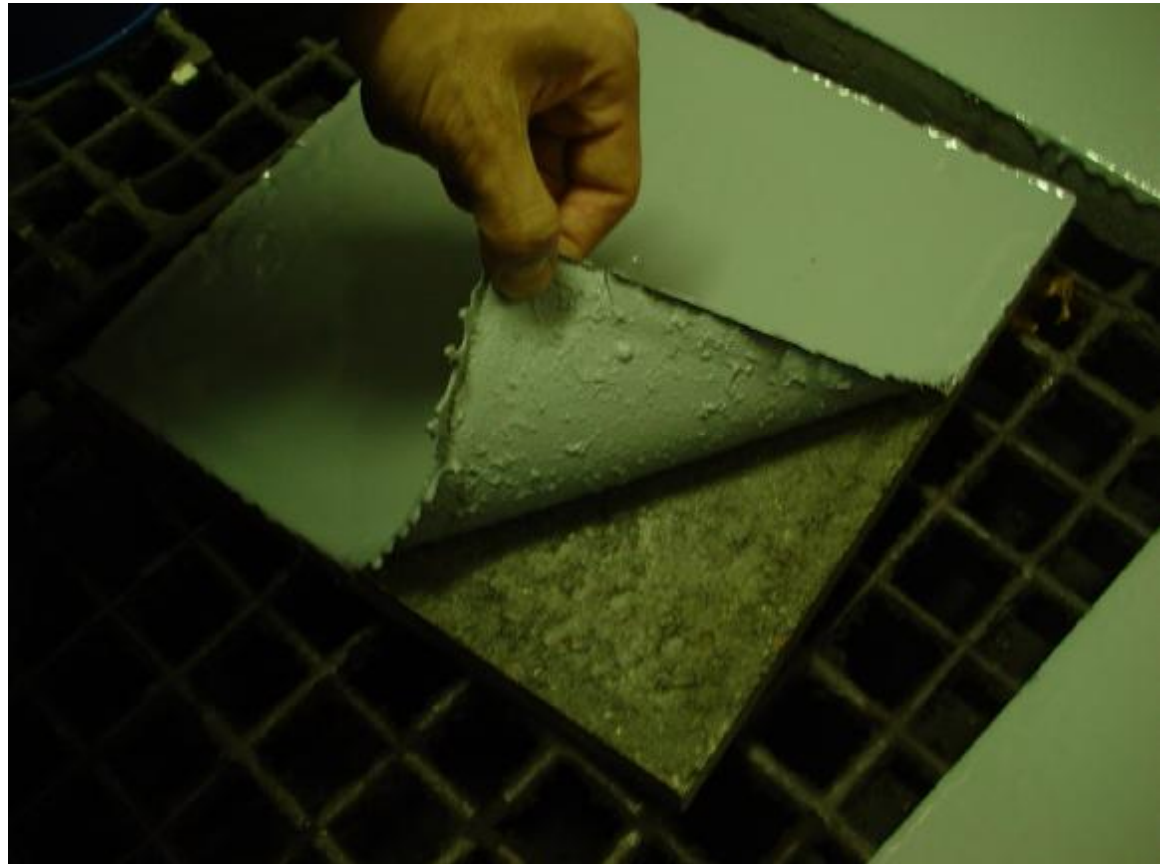
1. Spraying on a wet surface

Wet concrete surface during / after spray

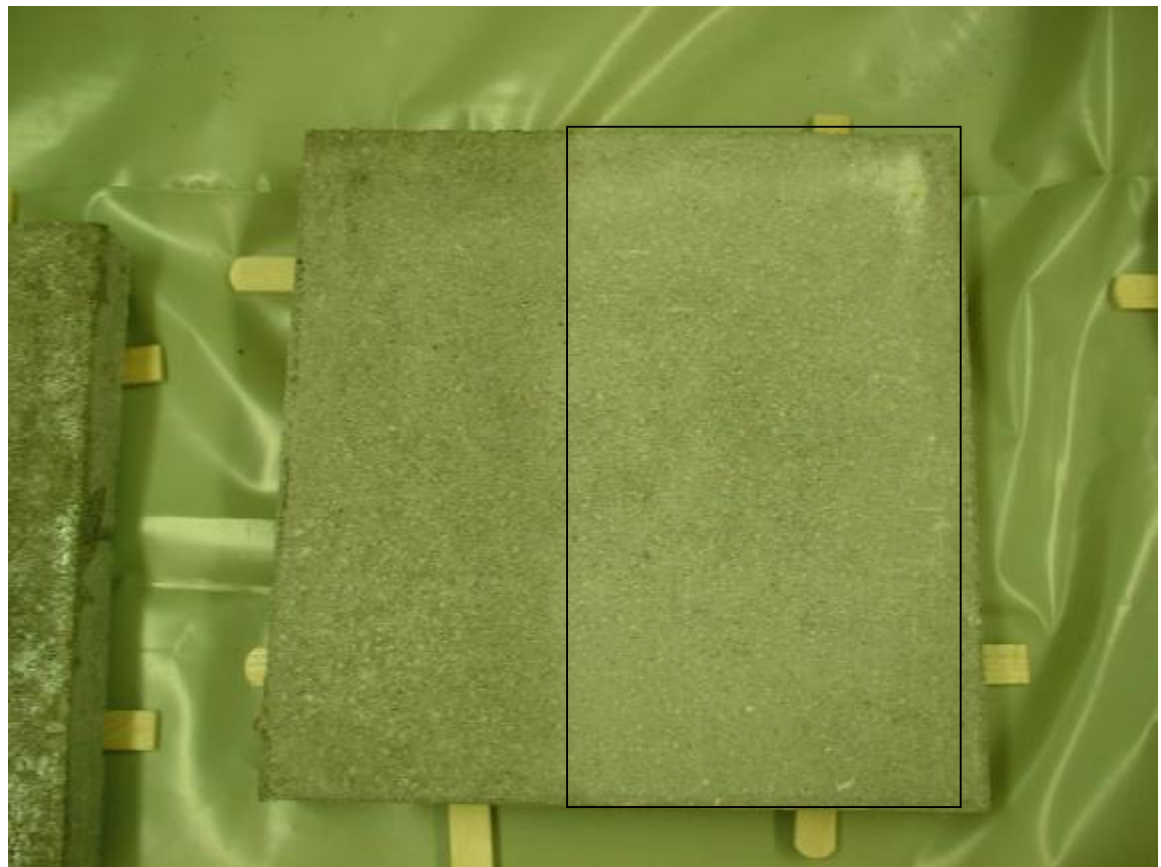
2. Unprimed surface

Unprimed dry concrete surface

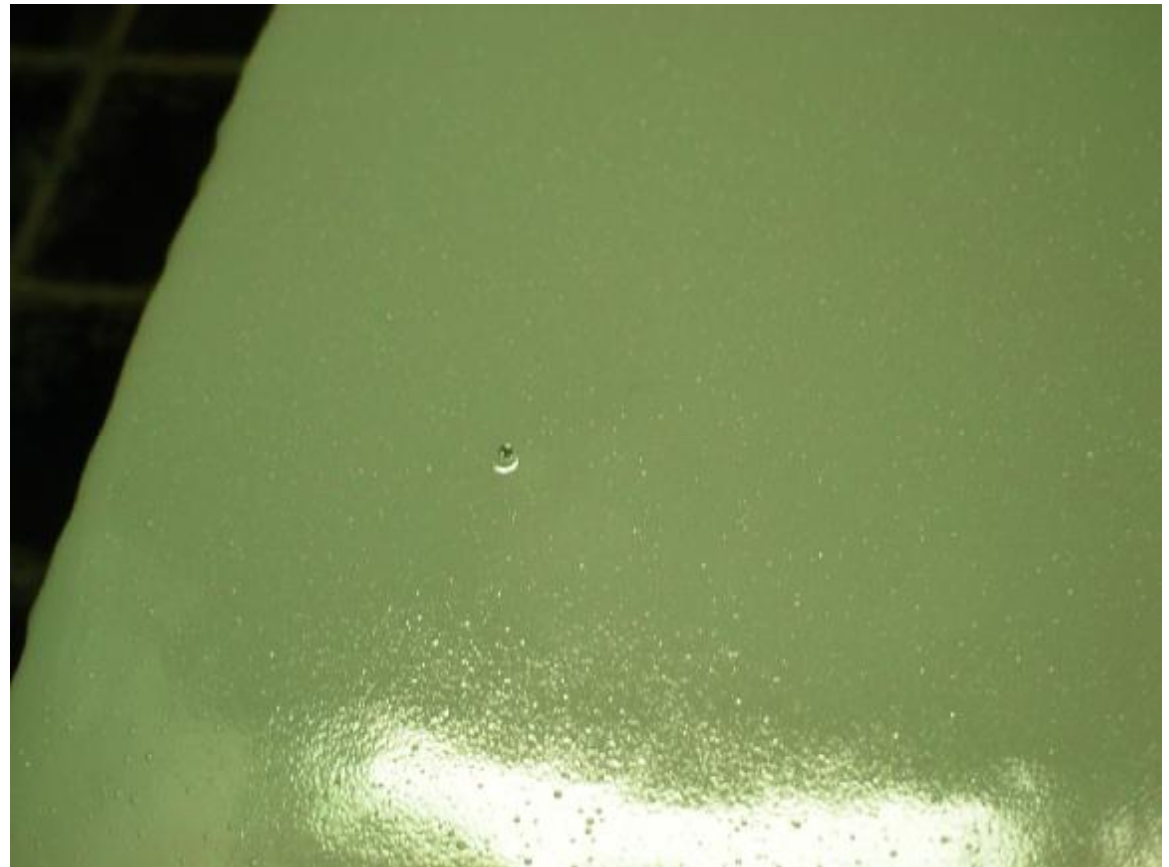
2. Unprimed surface

Unprimed dry concrete surface during spray

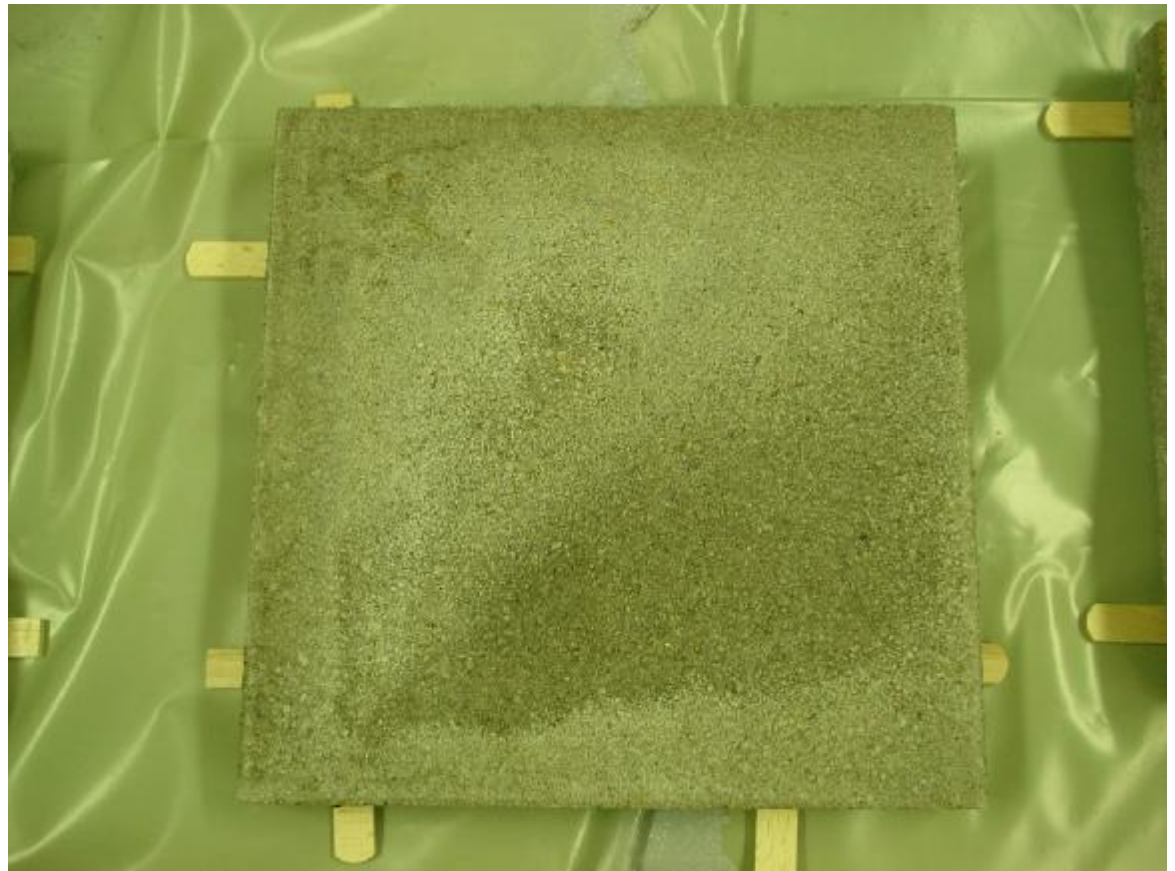
3. Primer coverage

Primer coverage not sufficient

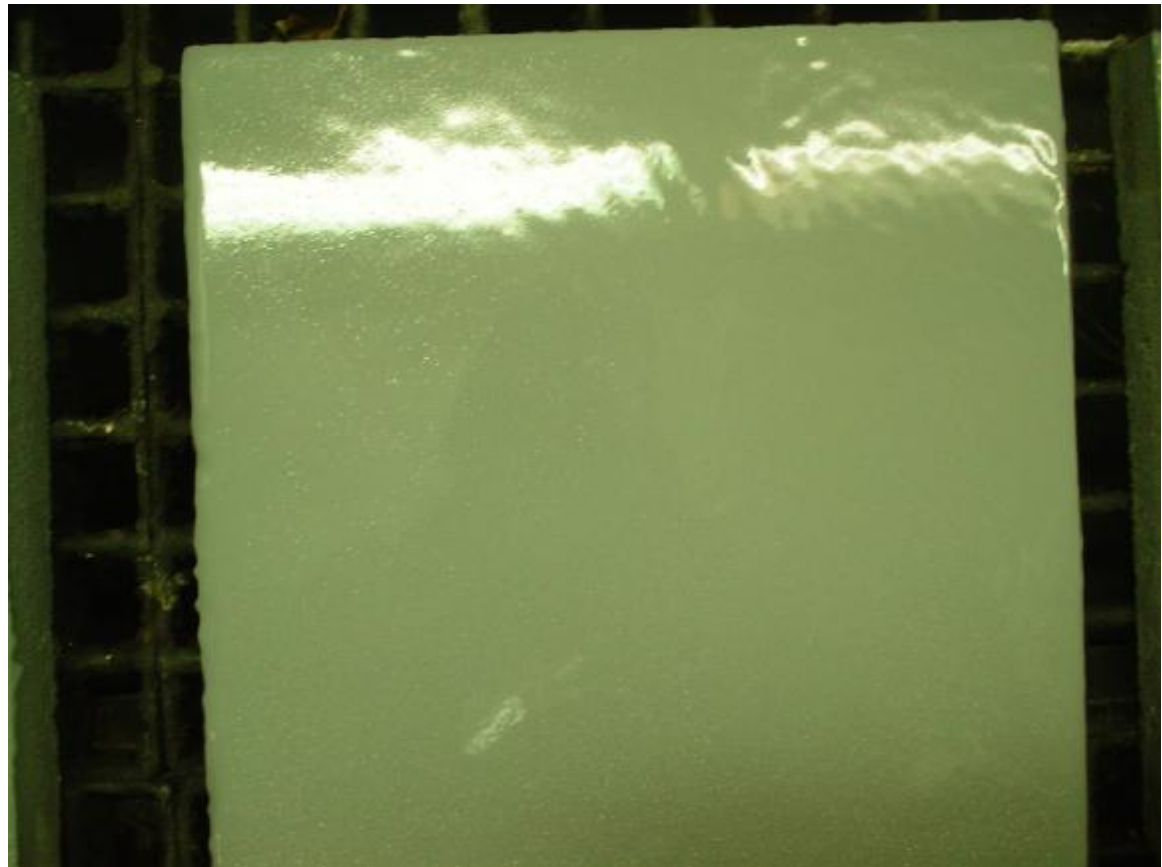
3. Primer coverage

Primer coverage not sufficient during / after spray but it still turned out OK.

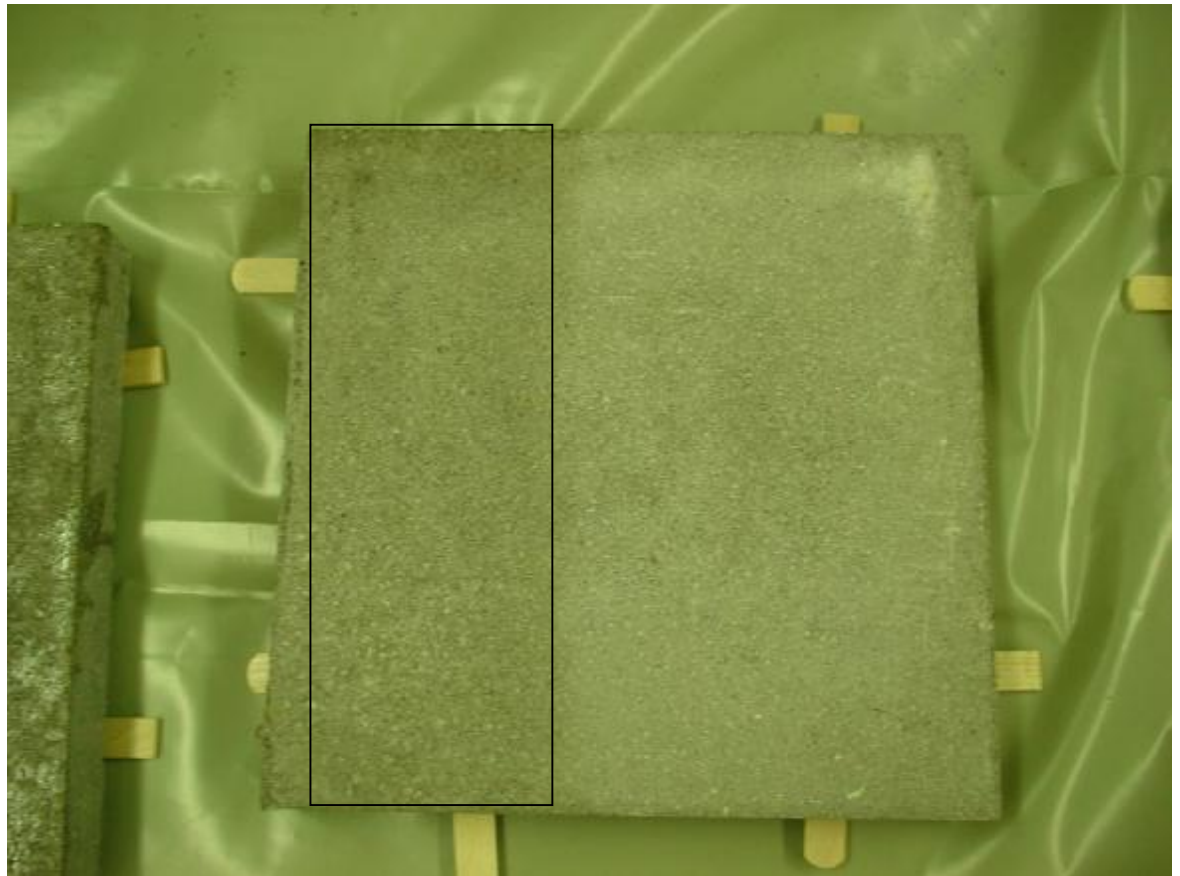
4. Primer used beyond pot life

Primer used beyond pot life

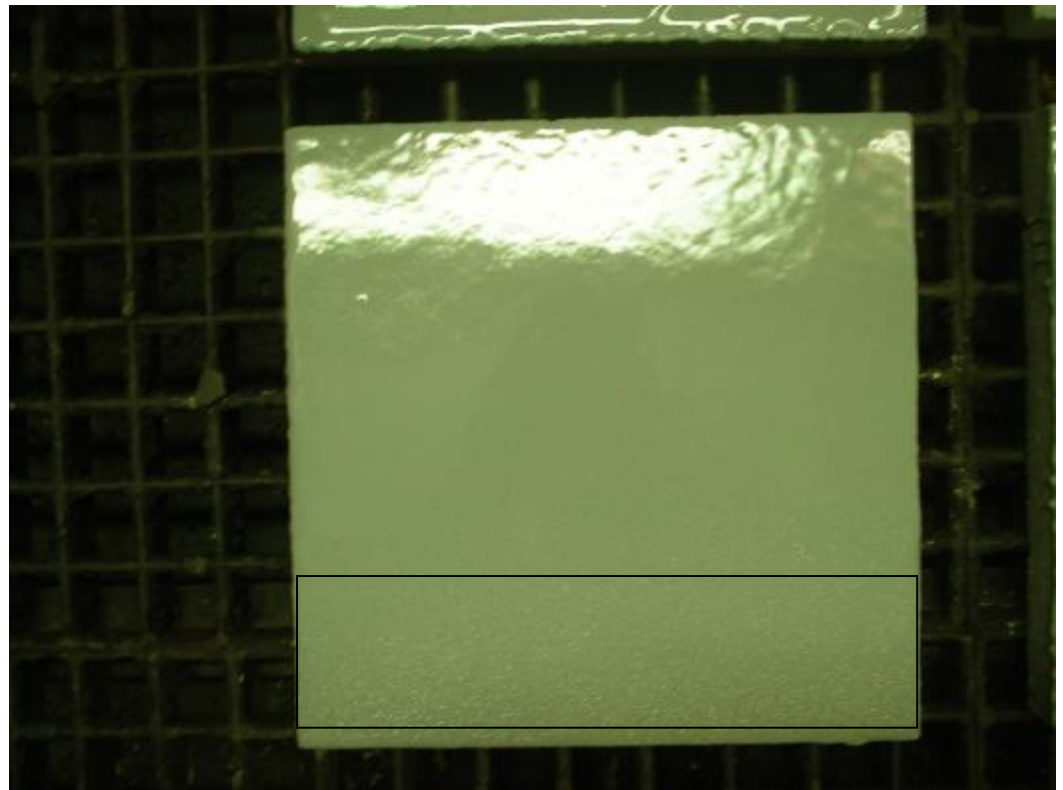
4. Primer used beyond pot life

Primer used beyond pot life after spray

Surface looks nice

Adhesion of primer to surface will be very low because primer did not wet surface

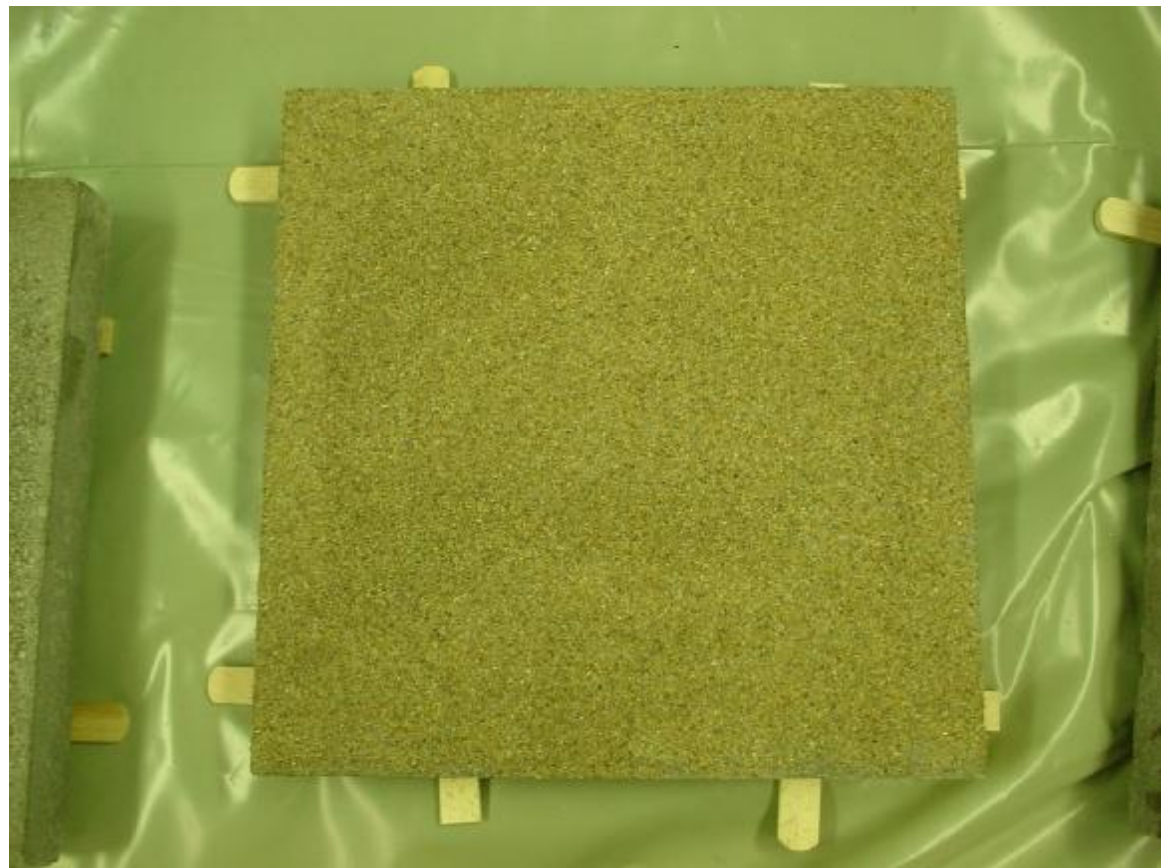
5. Broadcast sand

Primer surface with broadcast sand but not properly scrubbed

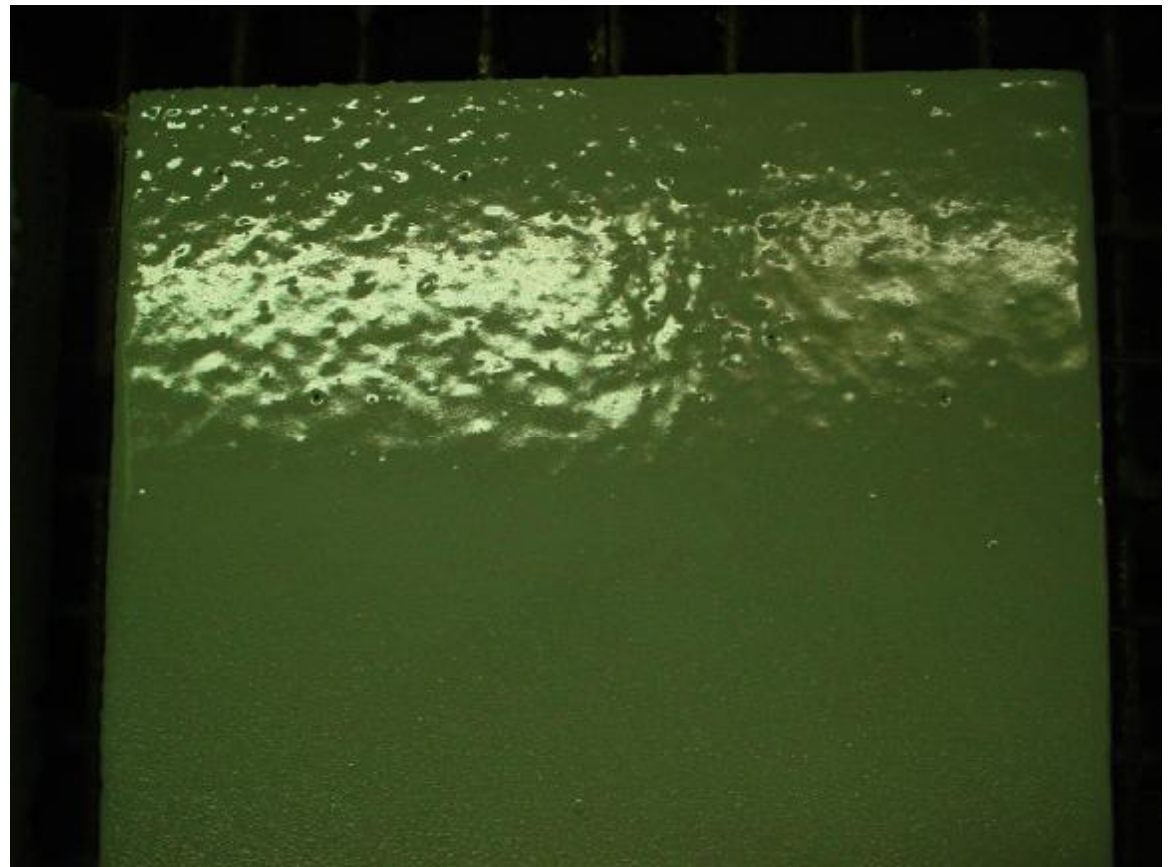
5. Broadcast sand

Primer surface with broadcast sand but not properly scrubbed during after spray

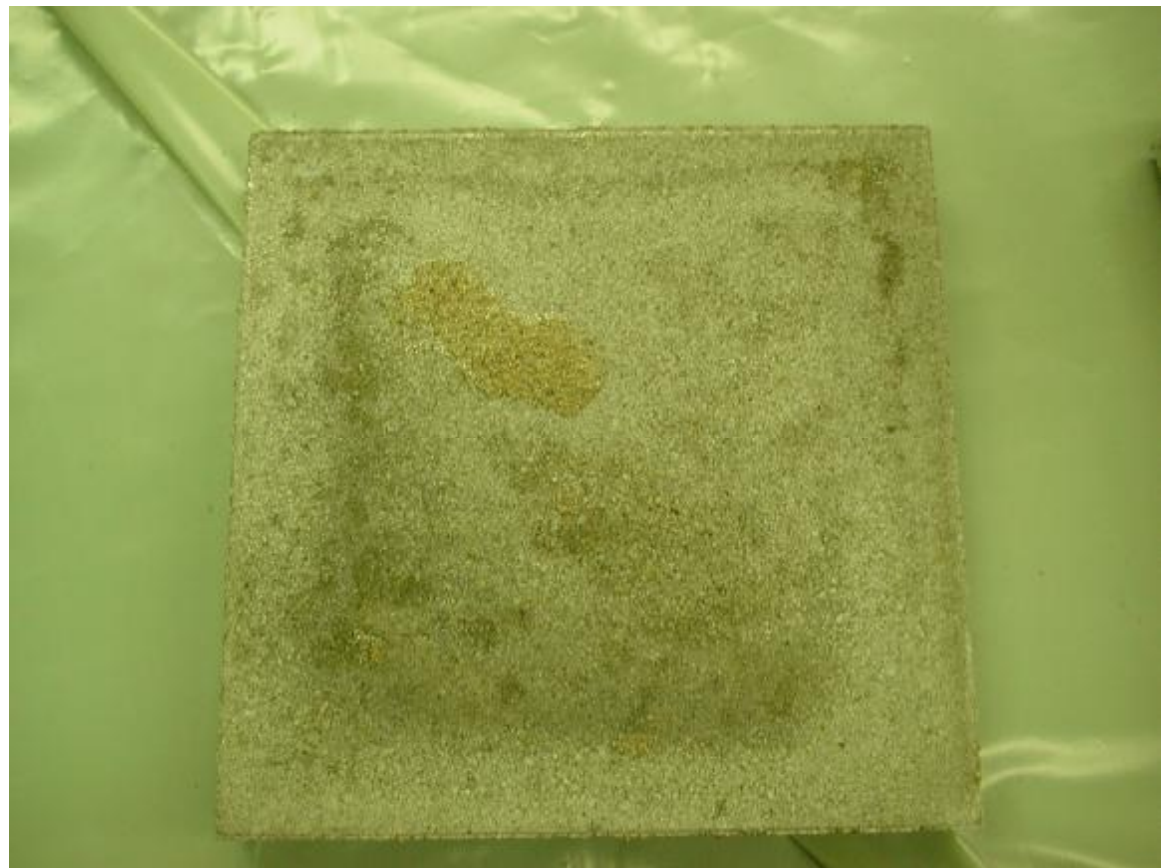
6. Primer errors

Errors in primer application such as spill or coating sand spills will show through membrane

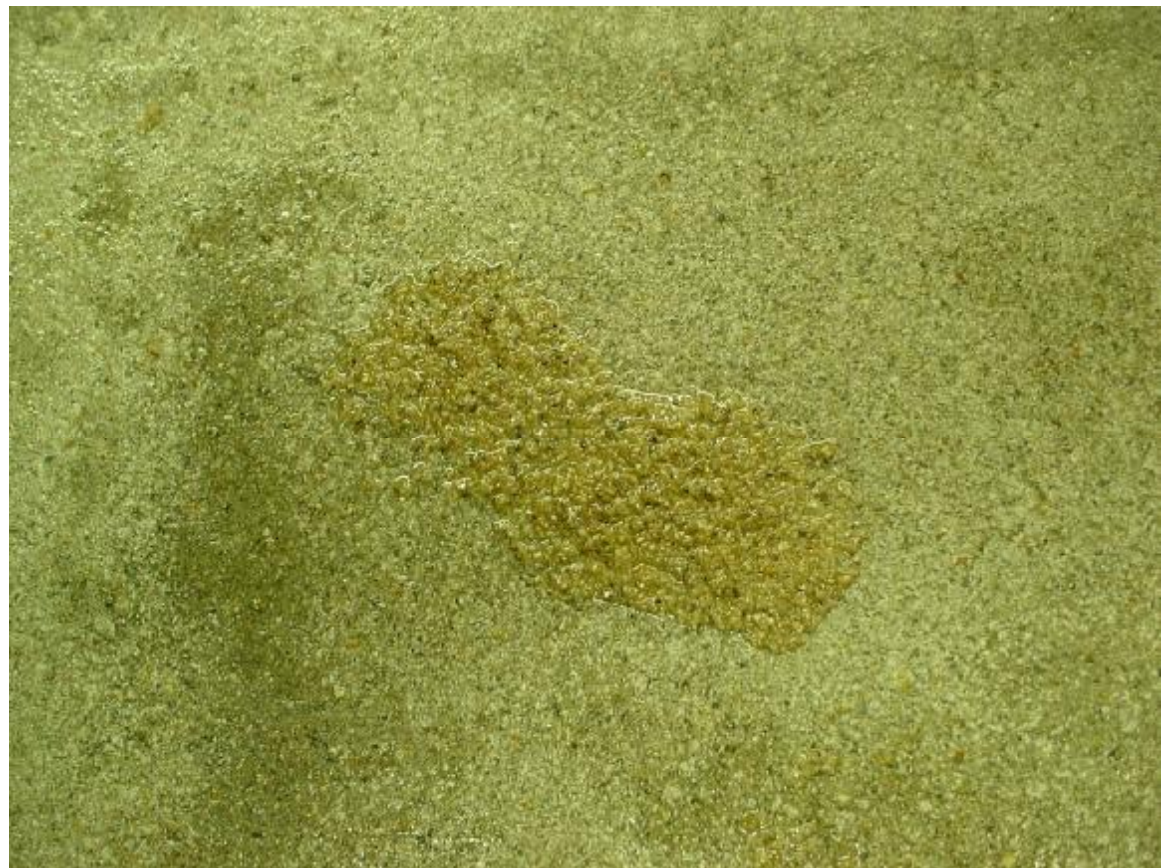
6. Primer errors

Errors in primer application such as spill or coating sand spills will show through membrane

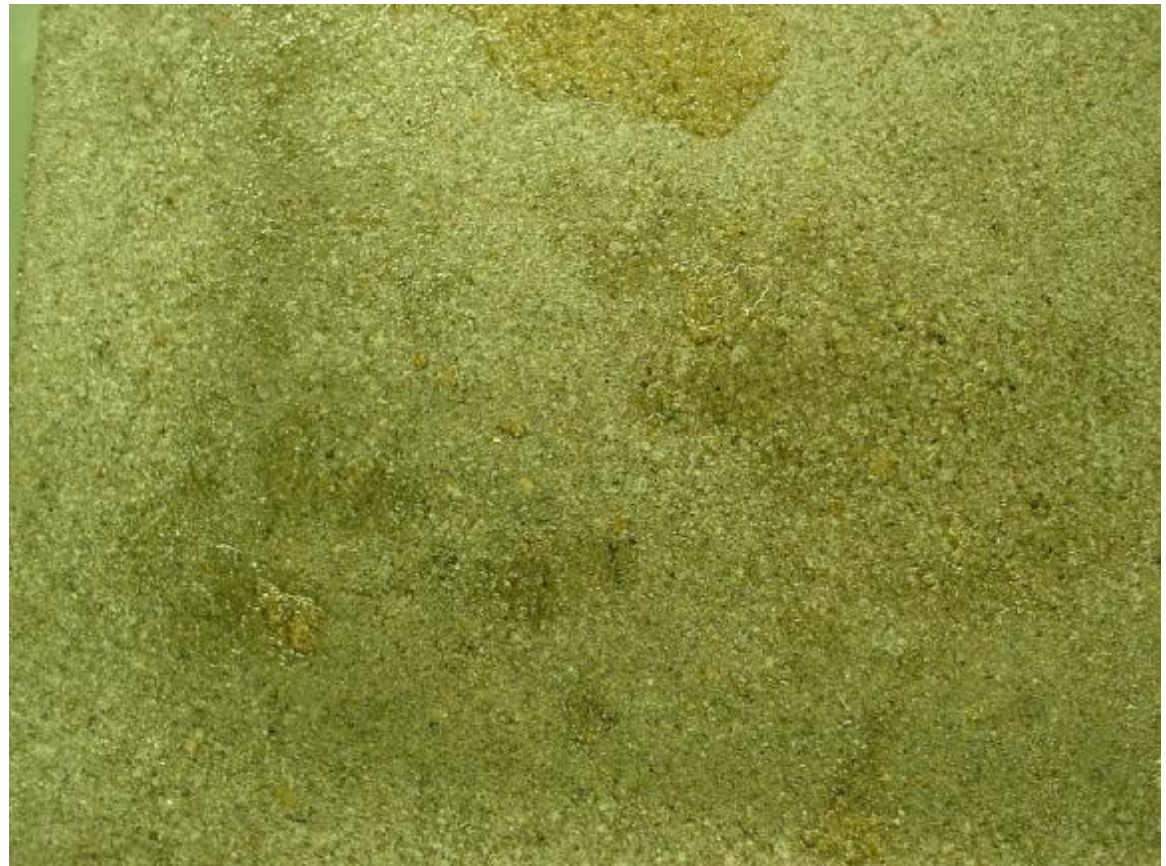
6. Primer errors

Errors in primer application such as spill or coating sand spills will show through membrane

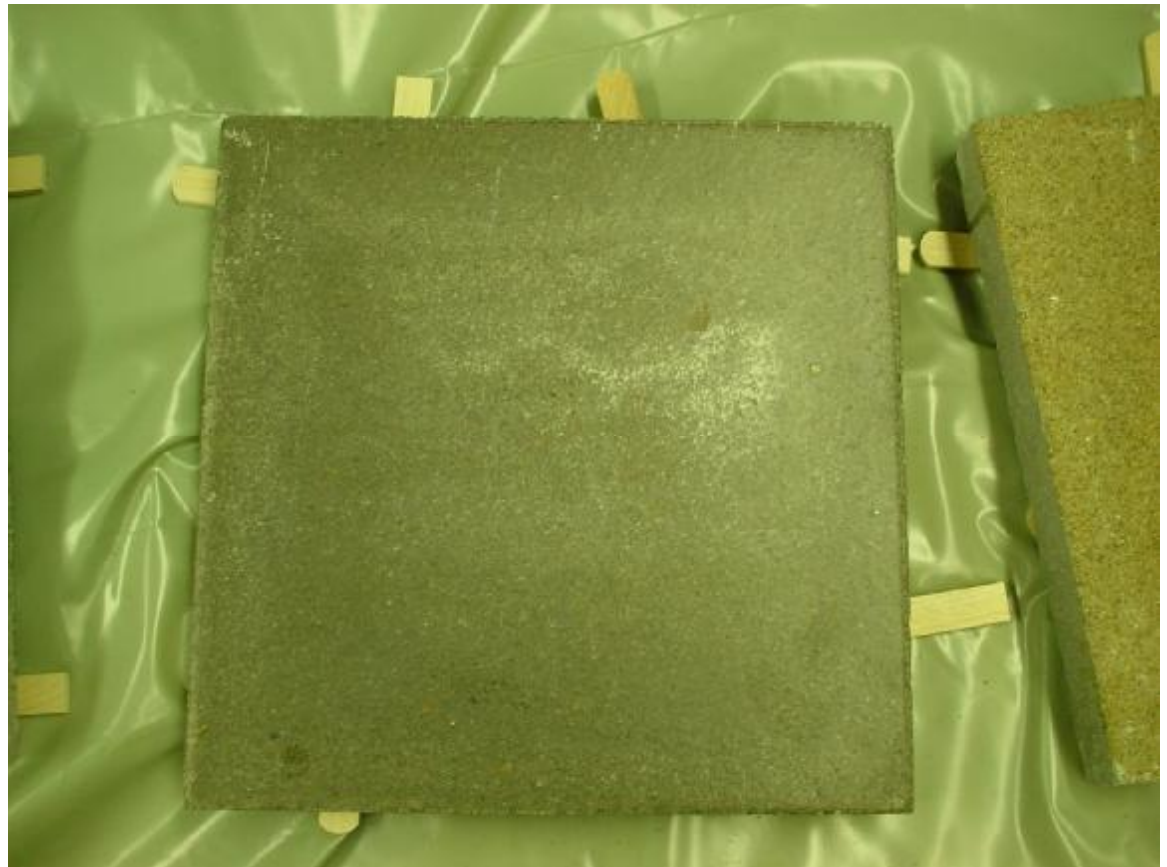
7. Full covering primer

But this primer has been applied 2 weeks ago and is beyond recoat time

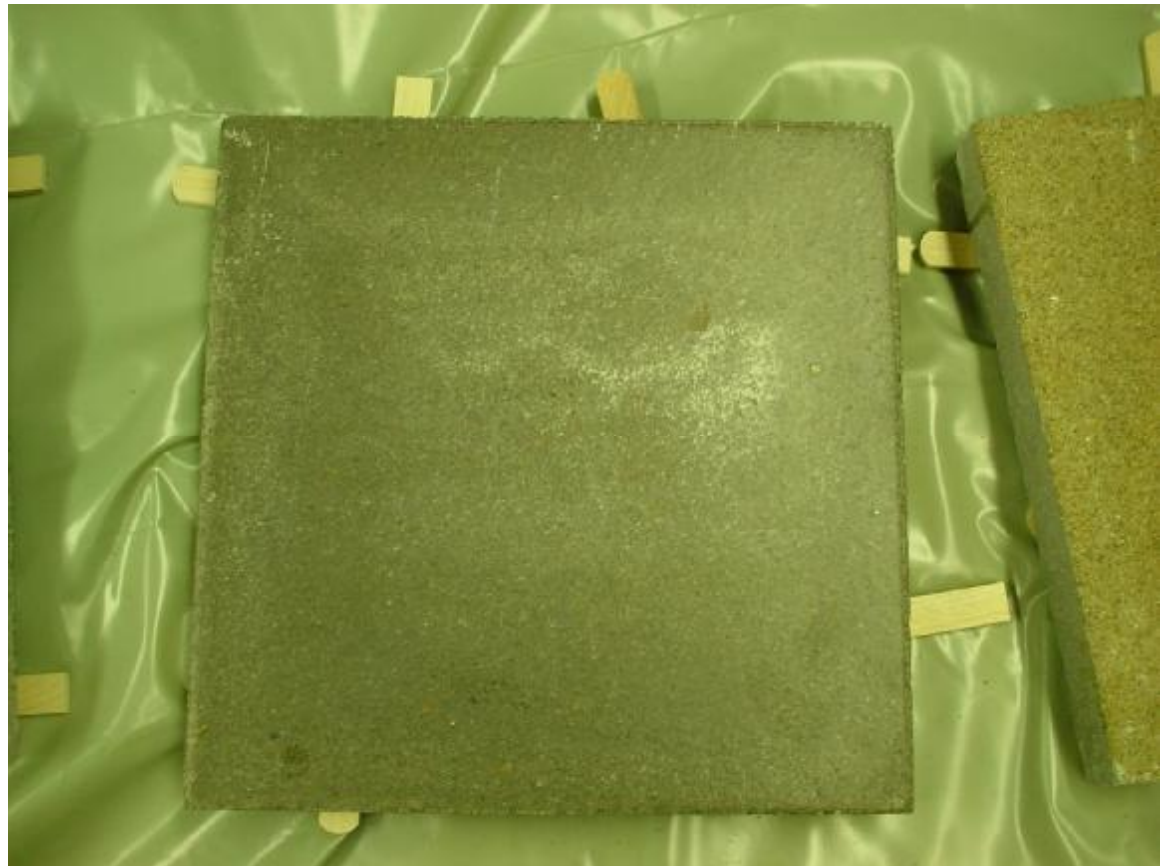
7. Full covering primer

2 problems are shown on this tile

Dirty finger

White spot amine blush

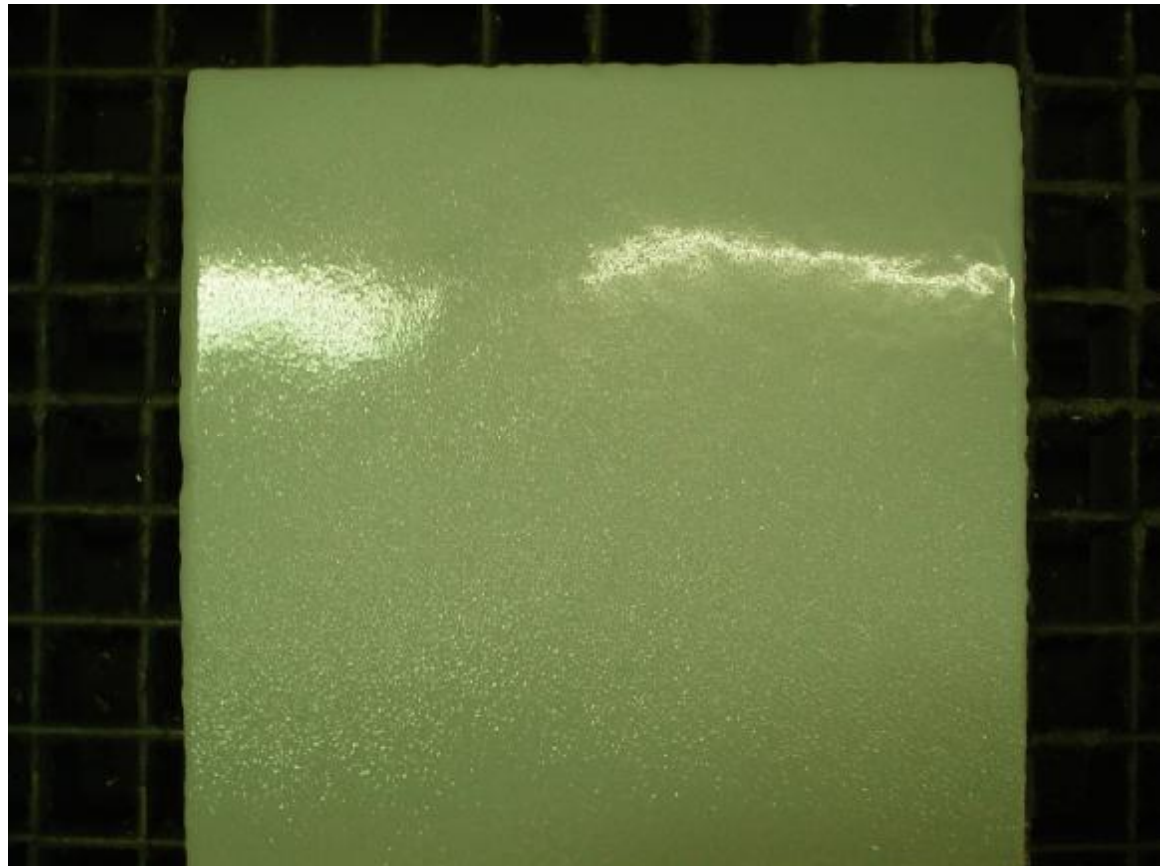
7. Full covering primer

Good surface for application of polyurea but adhesion will be low.

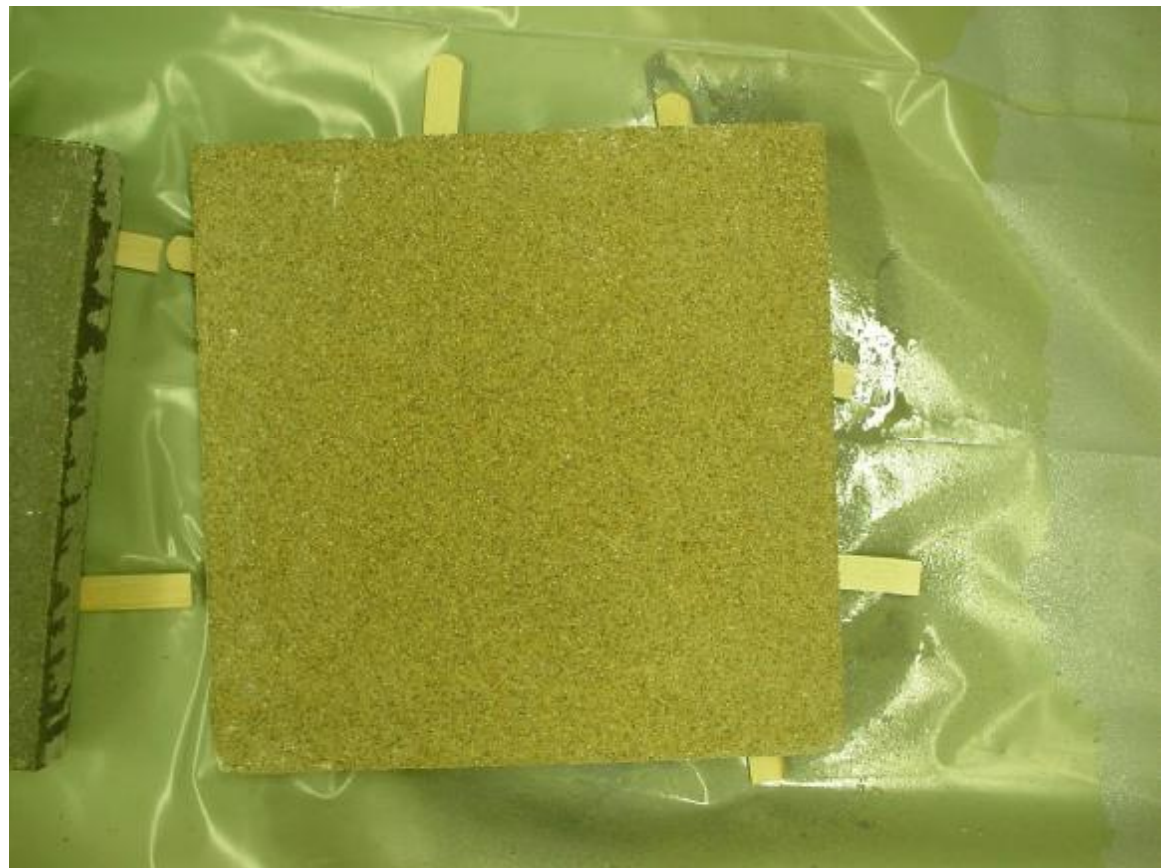
8. Full covering primer properly broadcast and scrubbed

This primer has also been applied 2 weeks ago and has been sanded and scrubbed

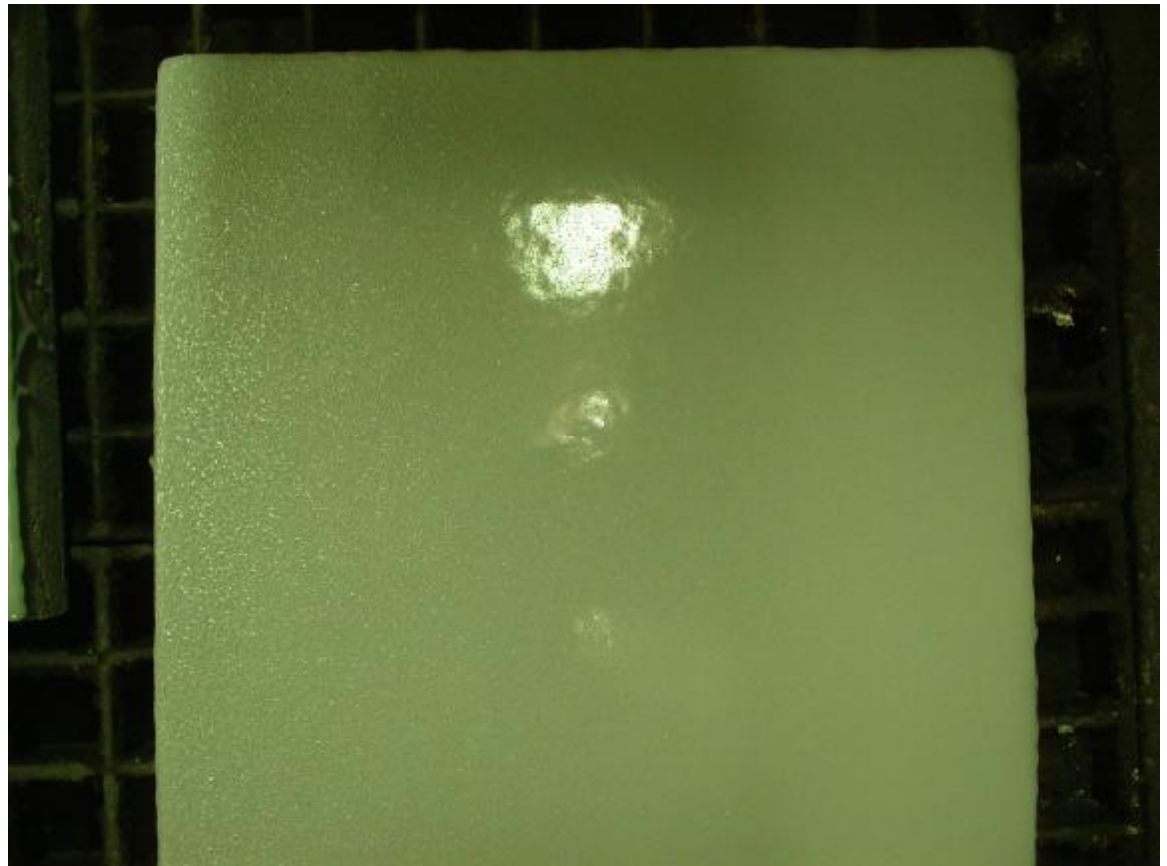
8. Full covering primer properly broadcast and scrubbed

This primer has also been applied 2 weeks ago and has been sanded and scrubbed after spray
