Job profile

- Project: rehabilitation of a desalination facility.
- Total area 12,000 sqm of pools and channels (in two parts)
- Location: Ashkelon- south of Israel (5 km from Gaza)
- Completed: April 2009
- Contractor: Sya-Group

Desanilation

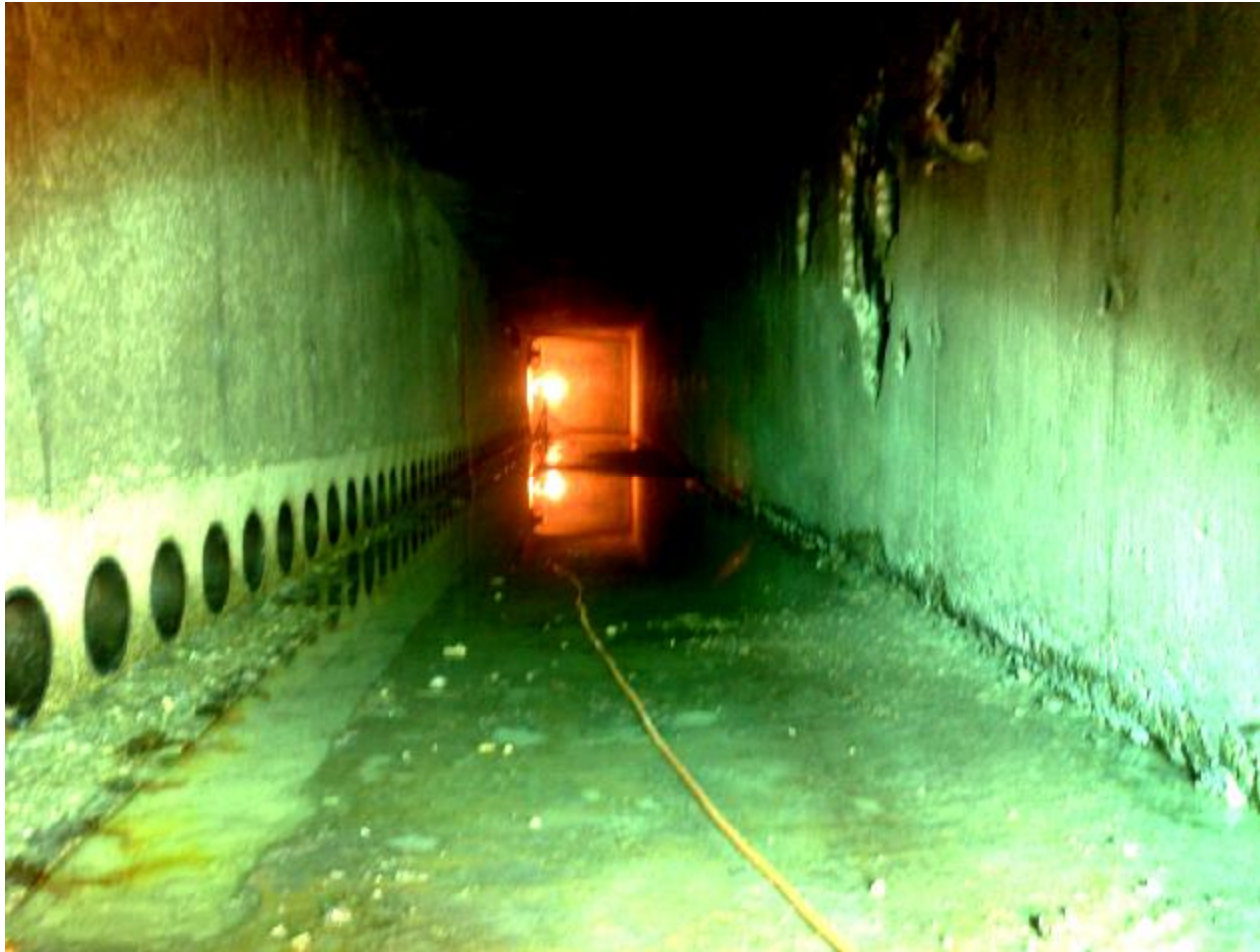
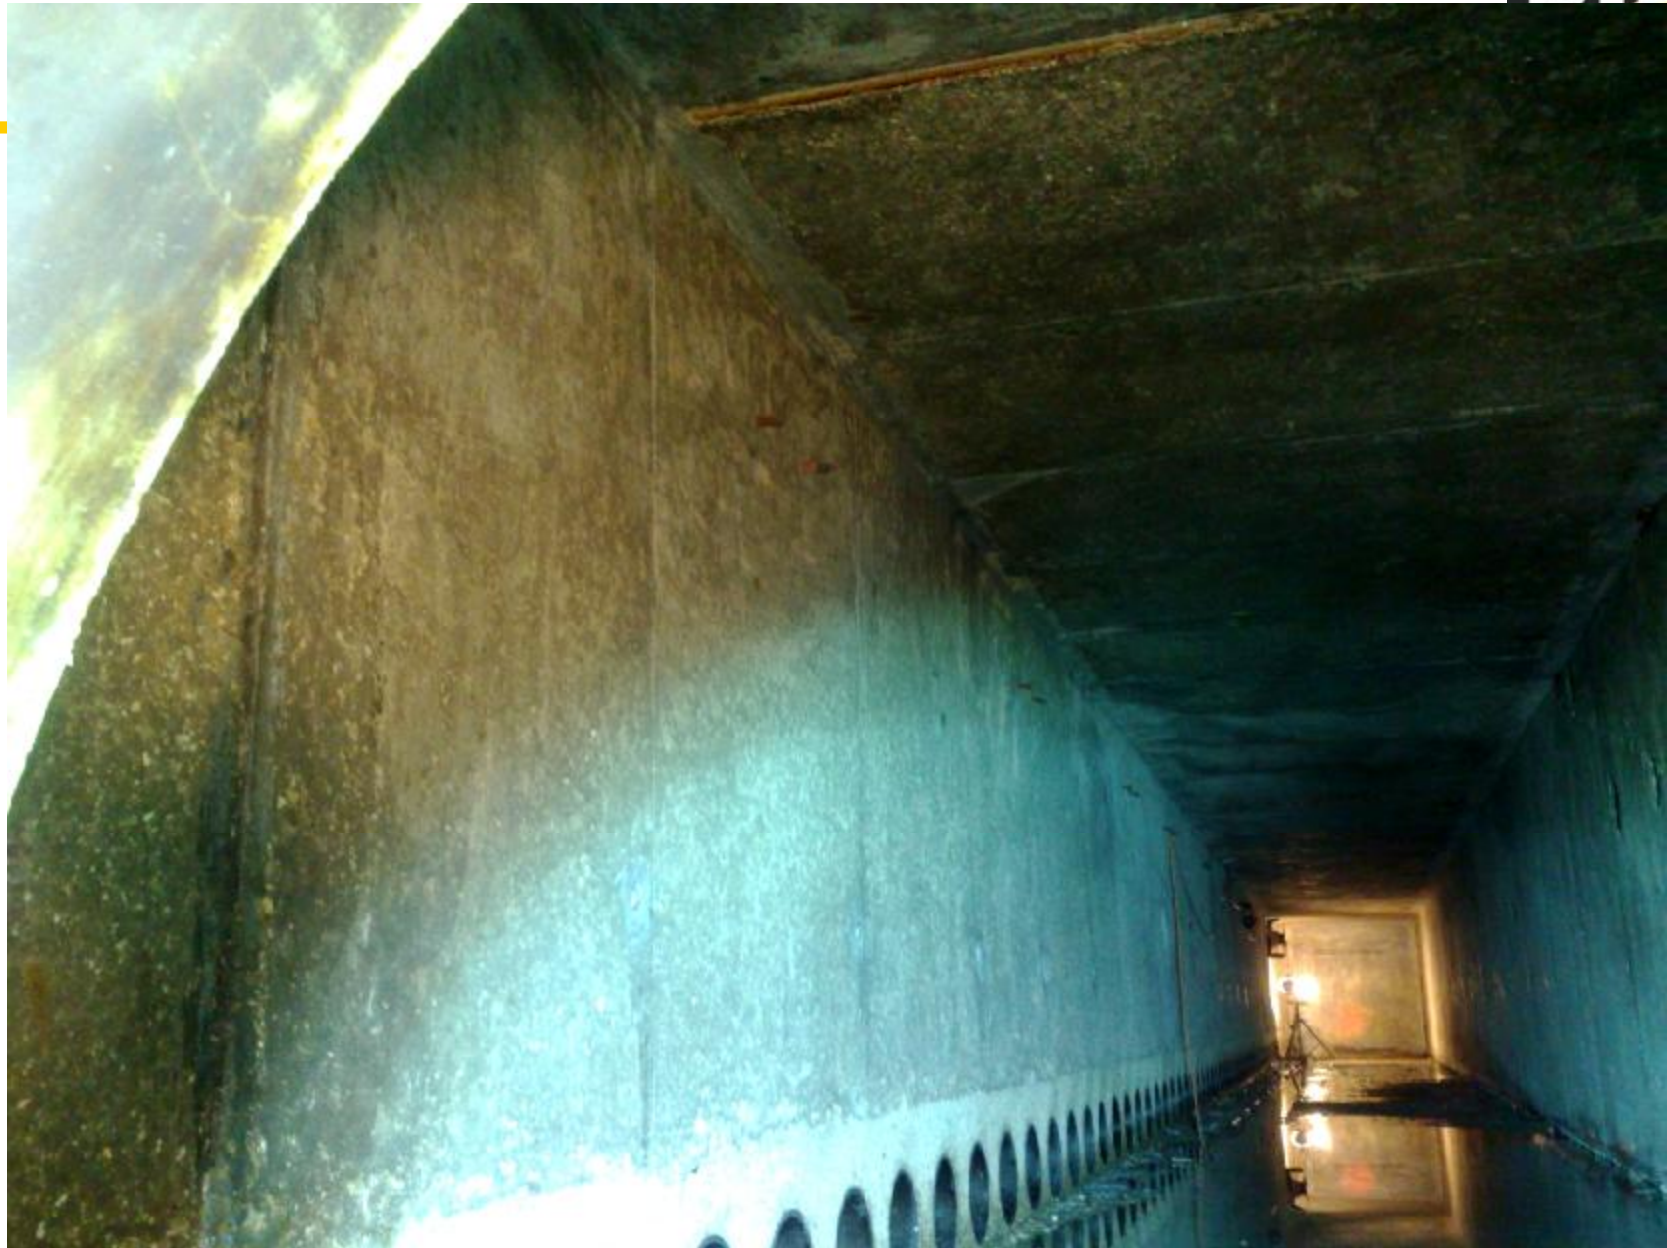
Water blasting

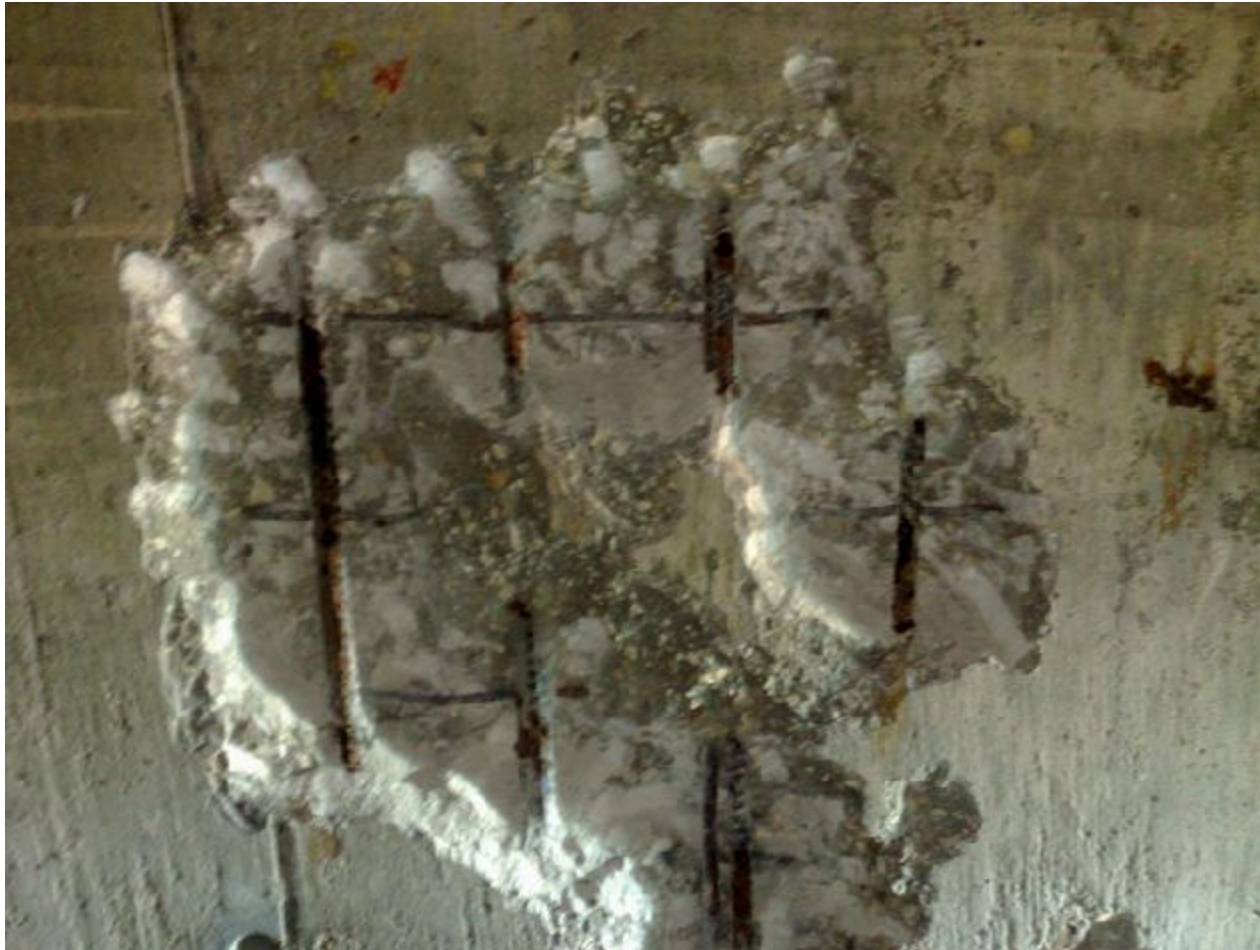
Exposed rebar

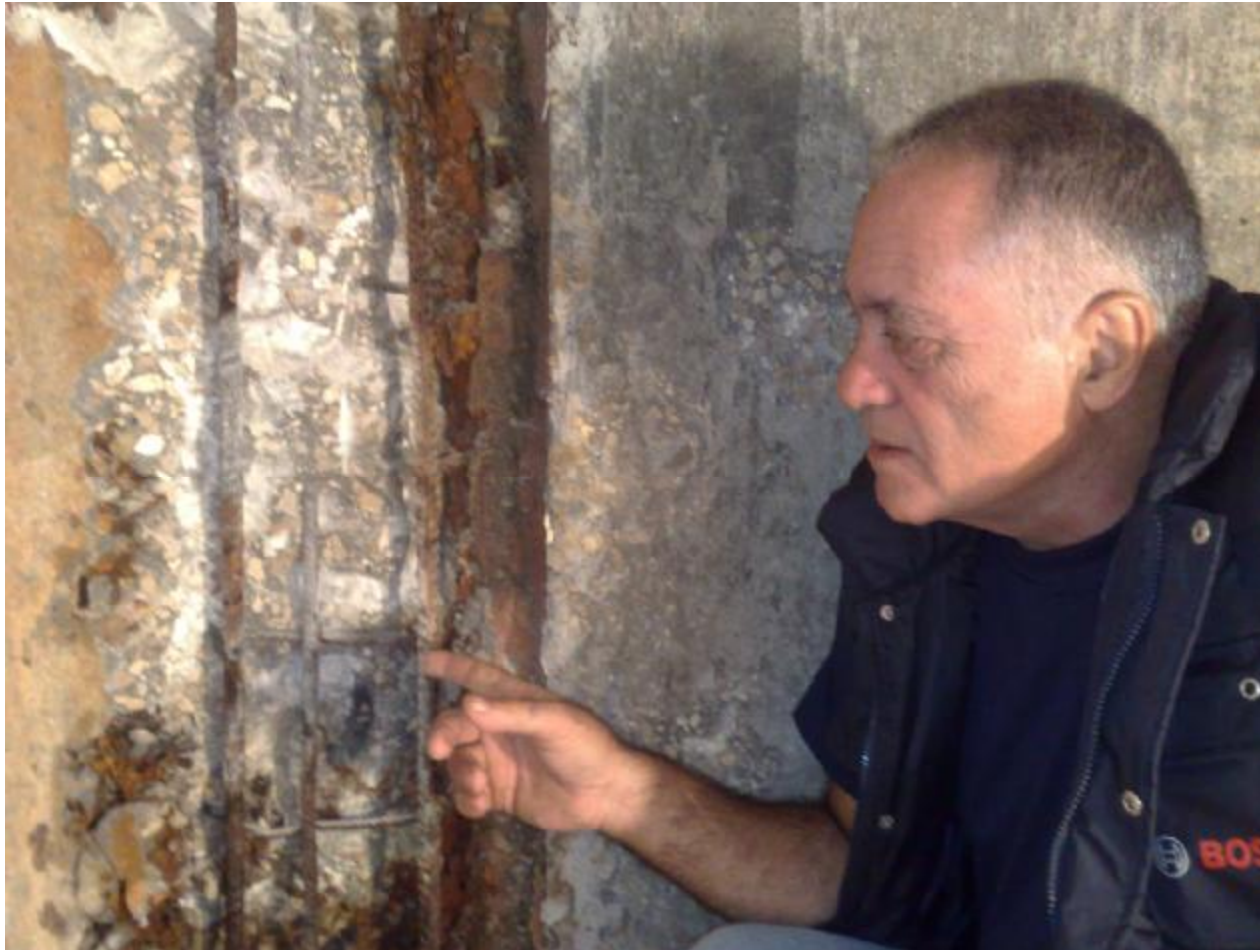
Rebars condition

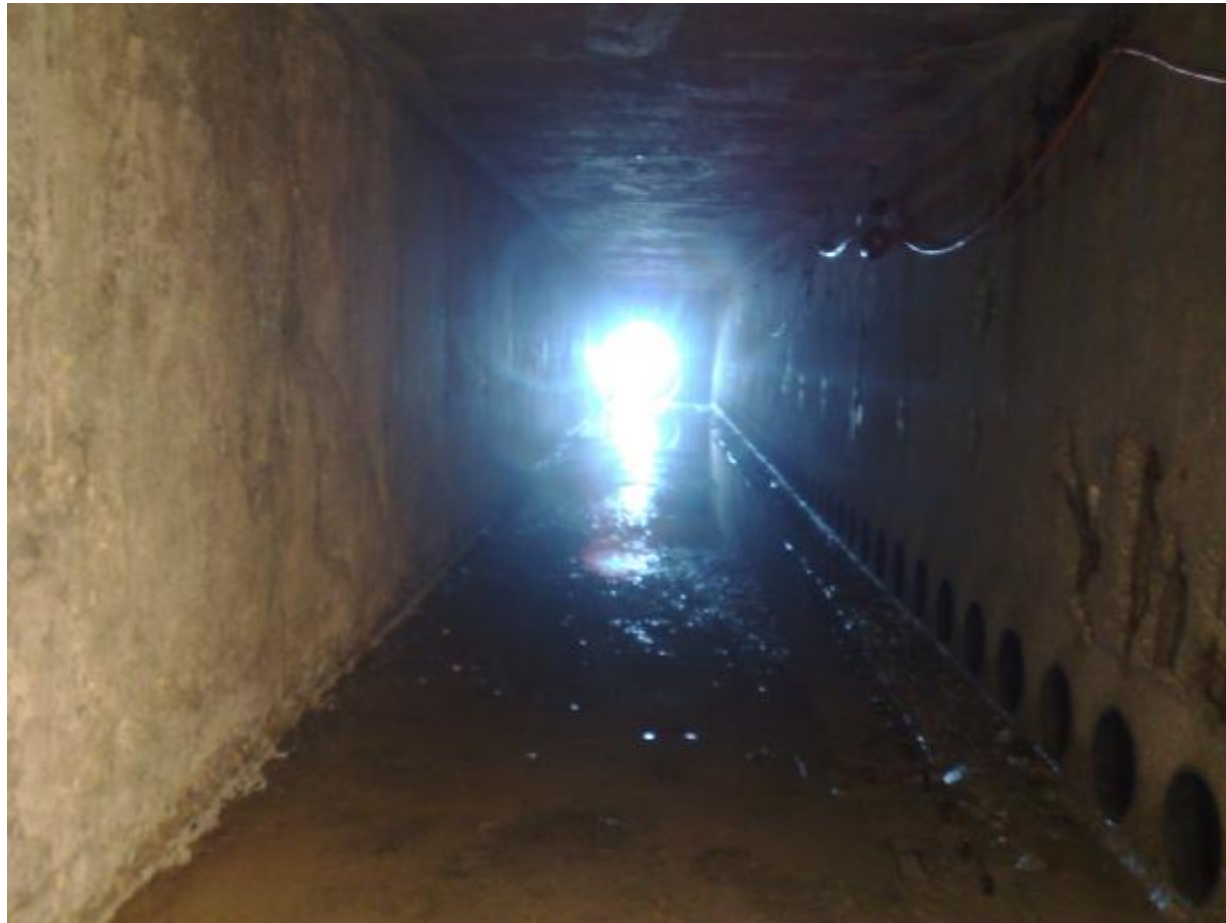
After using sika guard 720

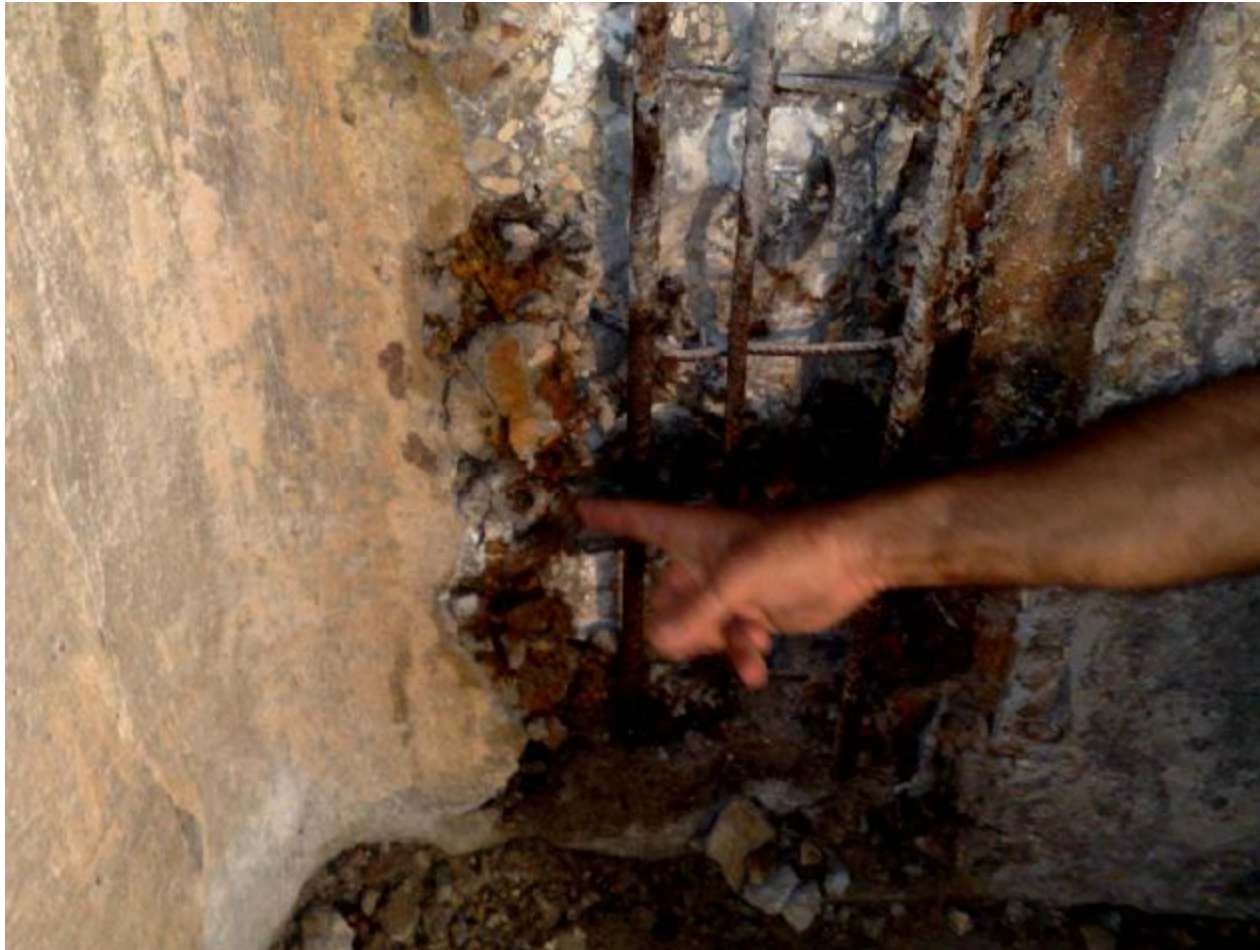
Using sika top 110\122

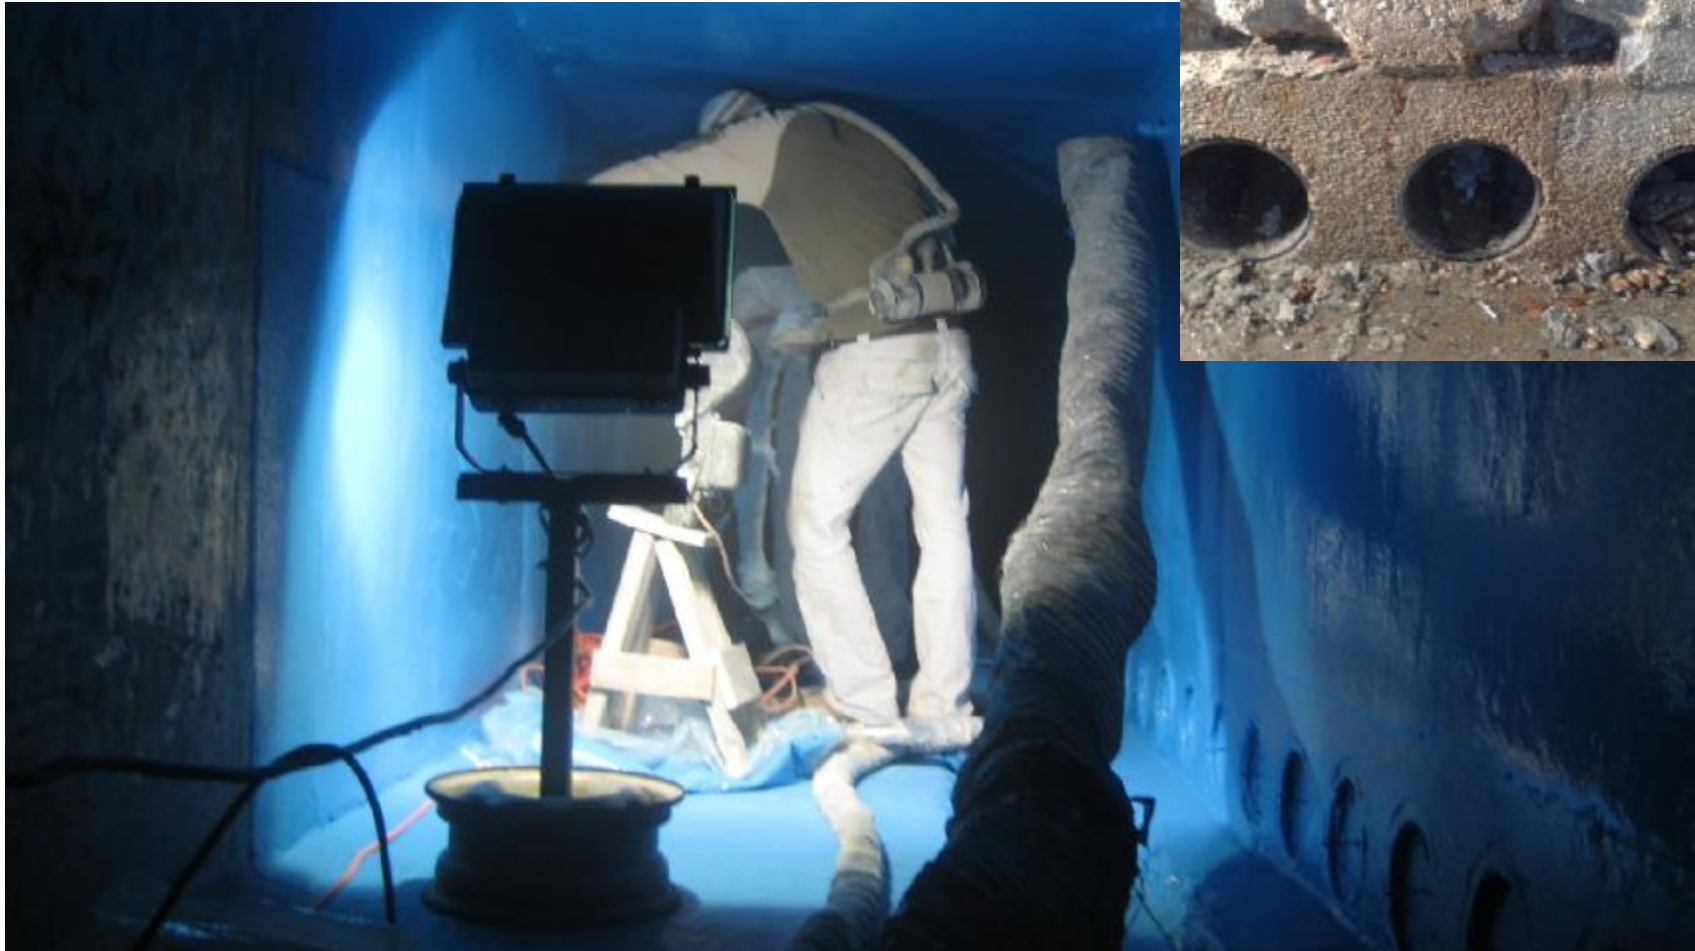
Spraying polyurea

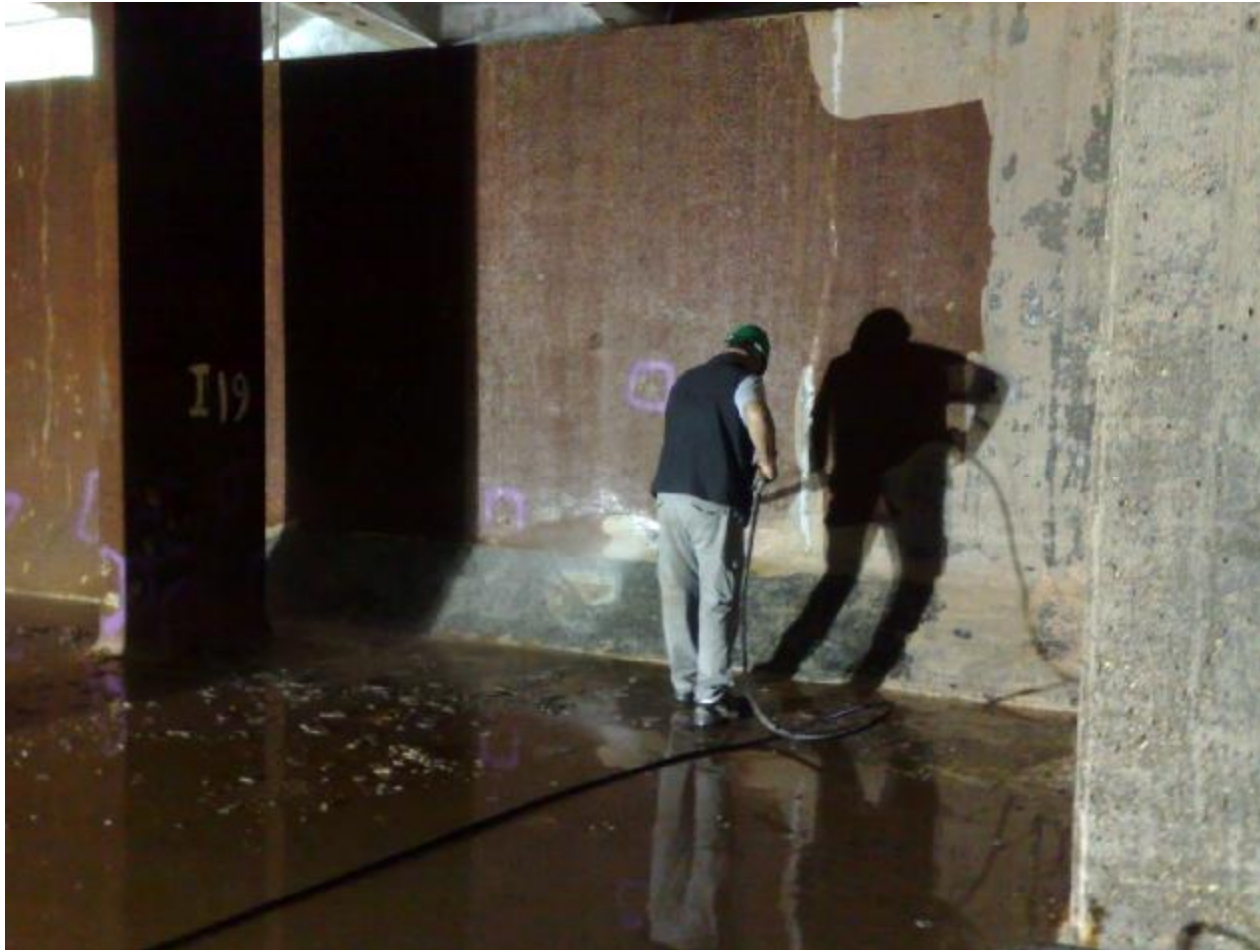
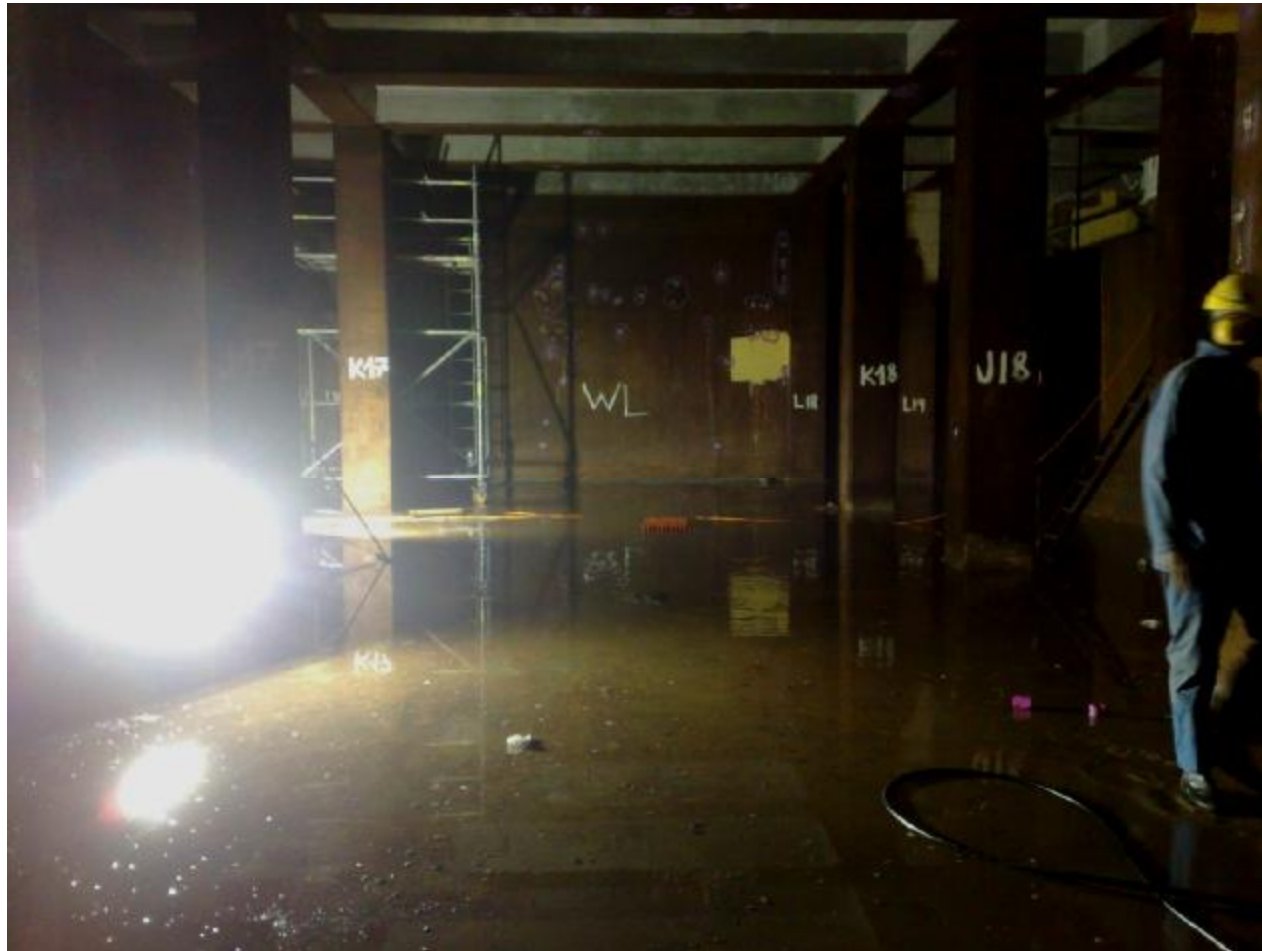
The tanks

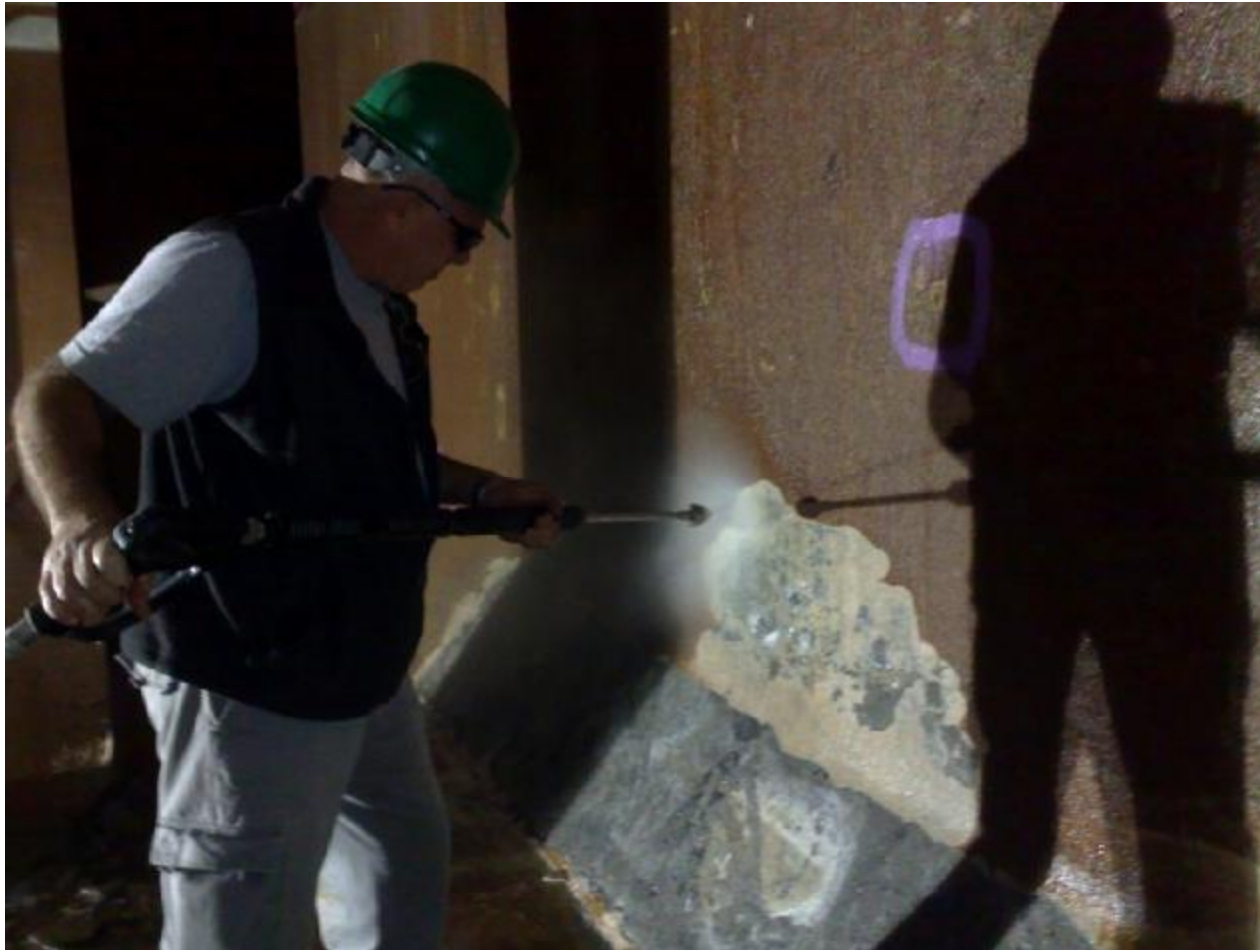
Remove sika guard 107

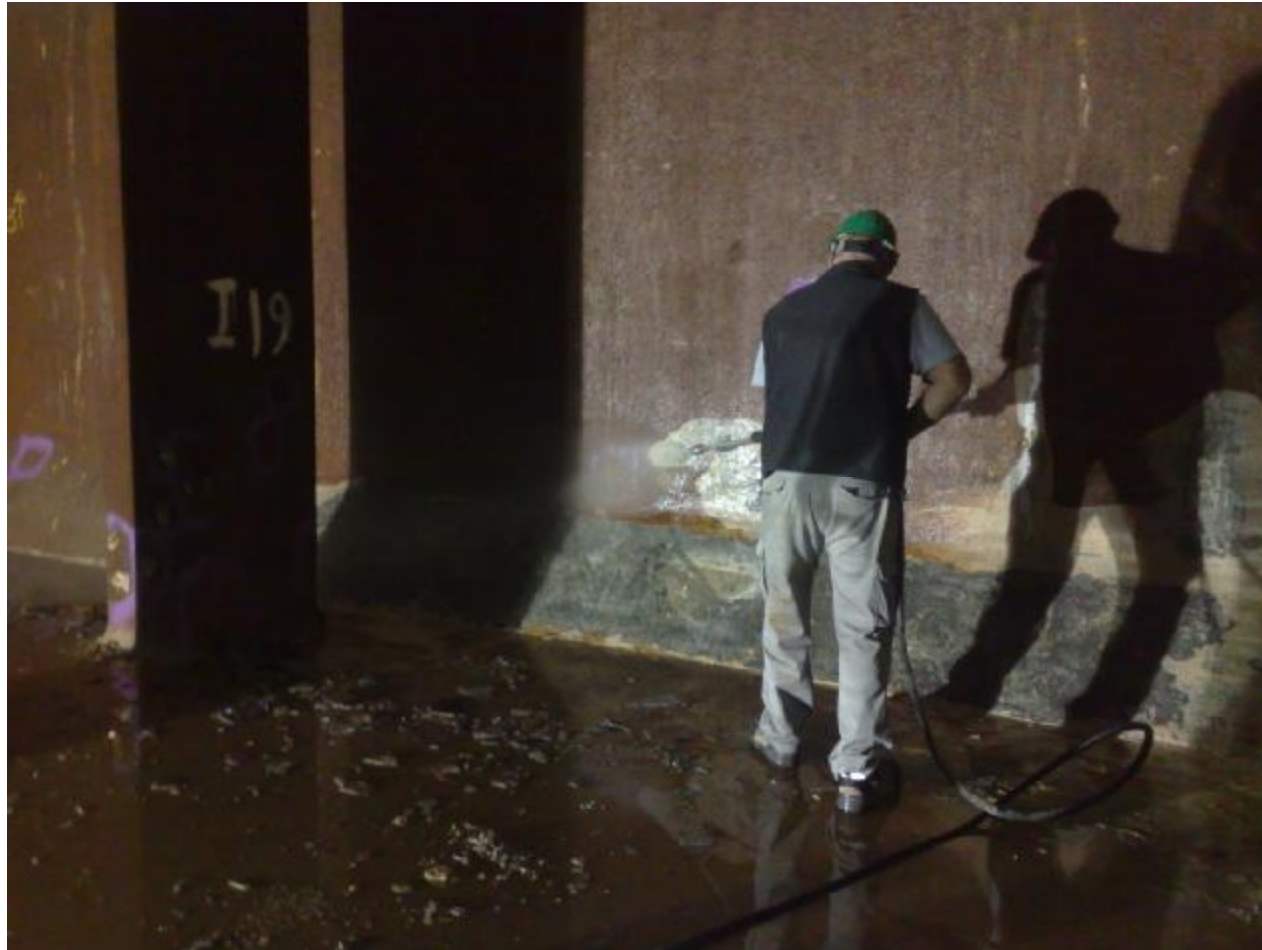
Using high pressure water

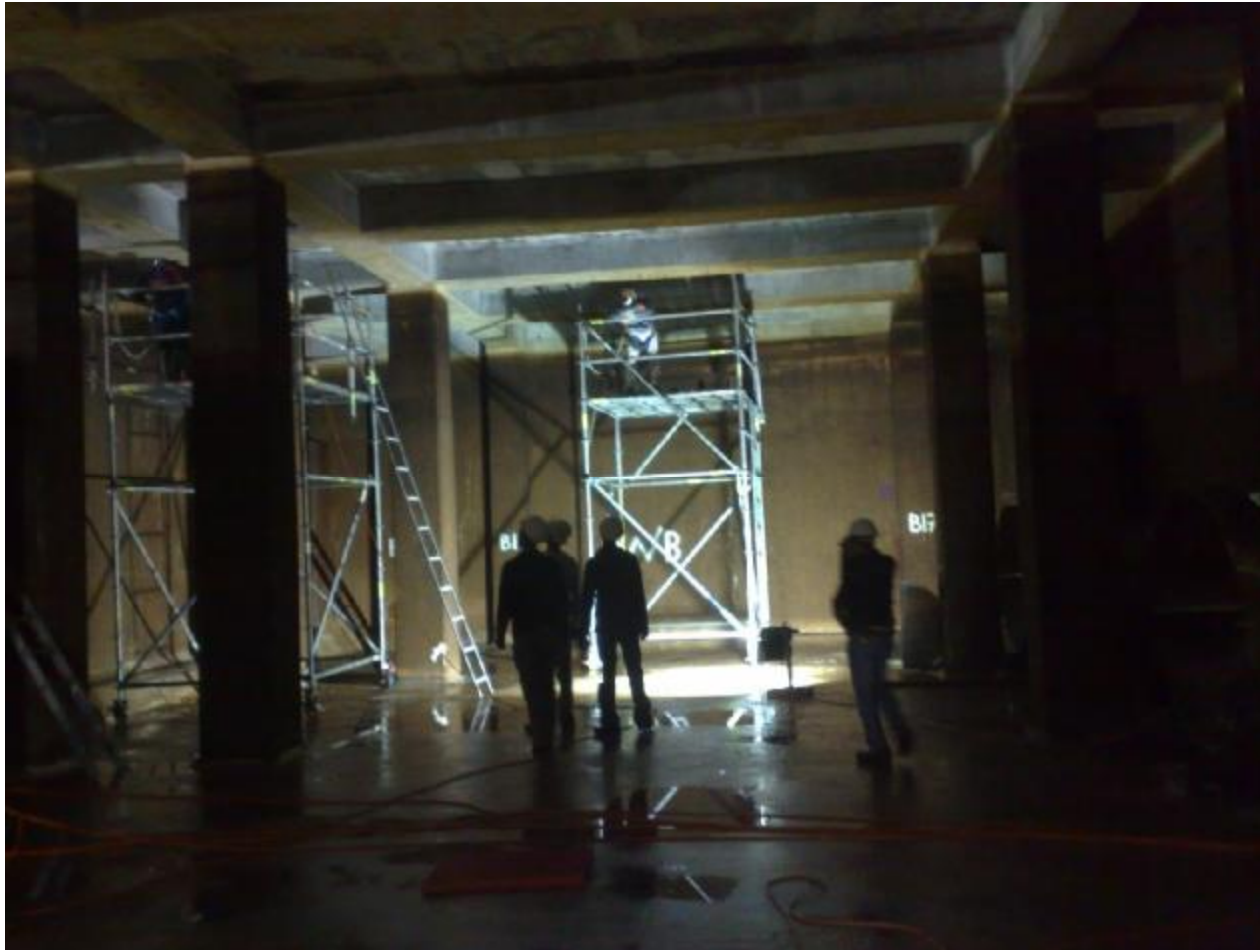
Looking for corrosion

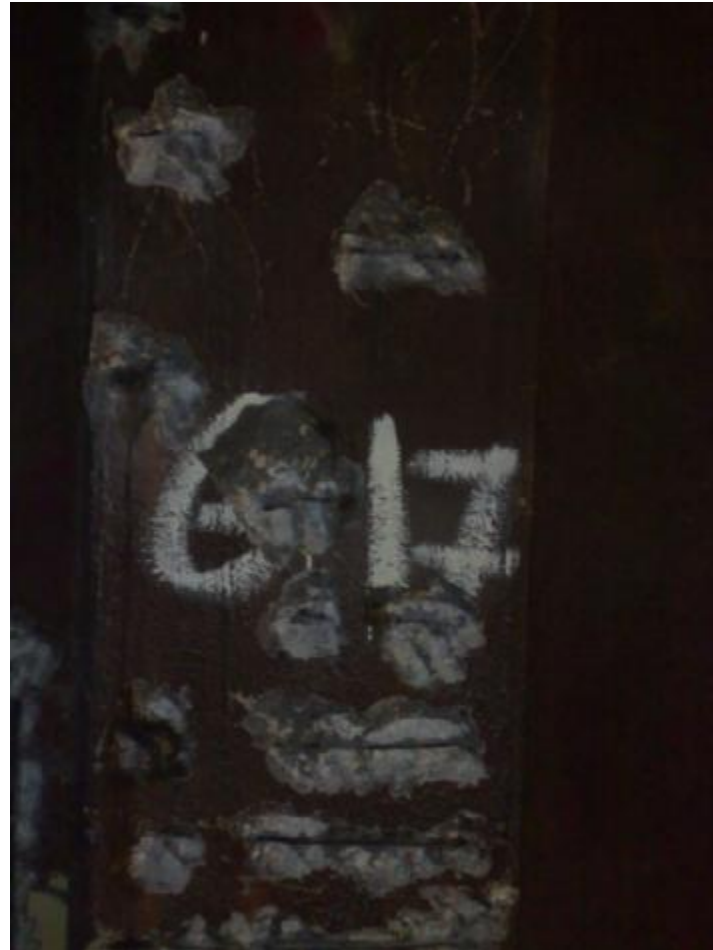
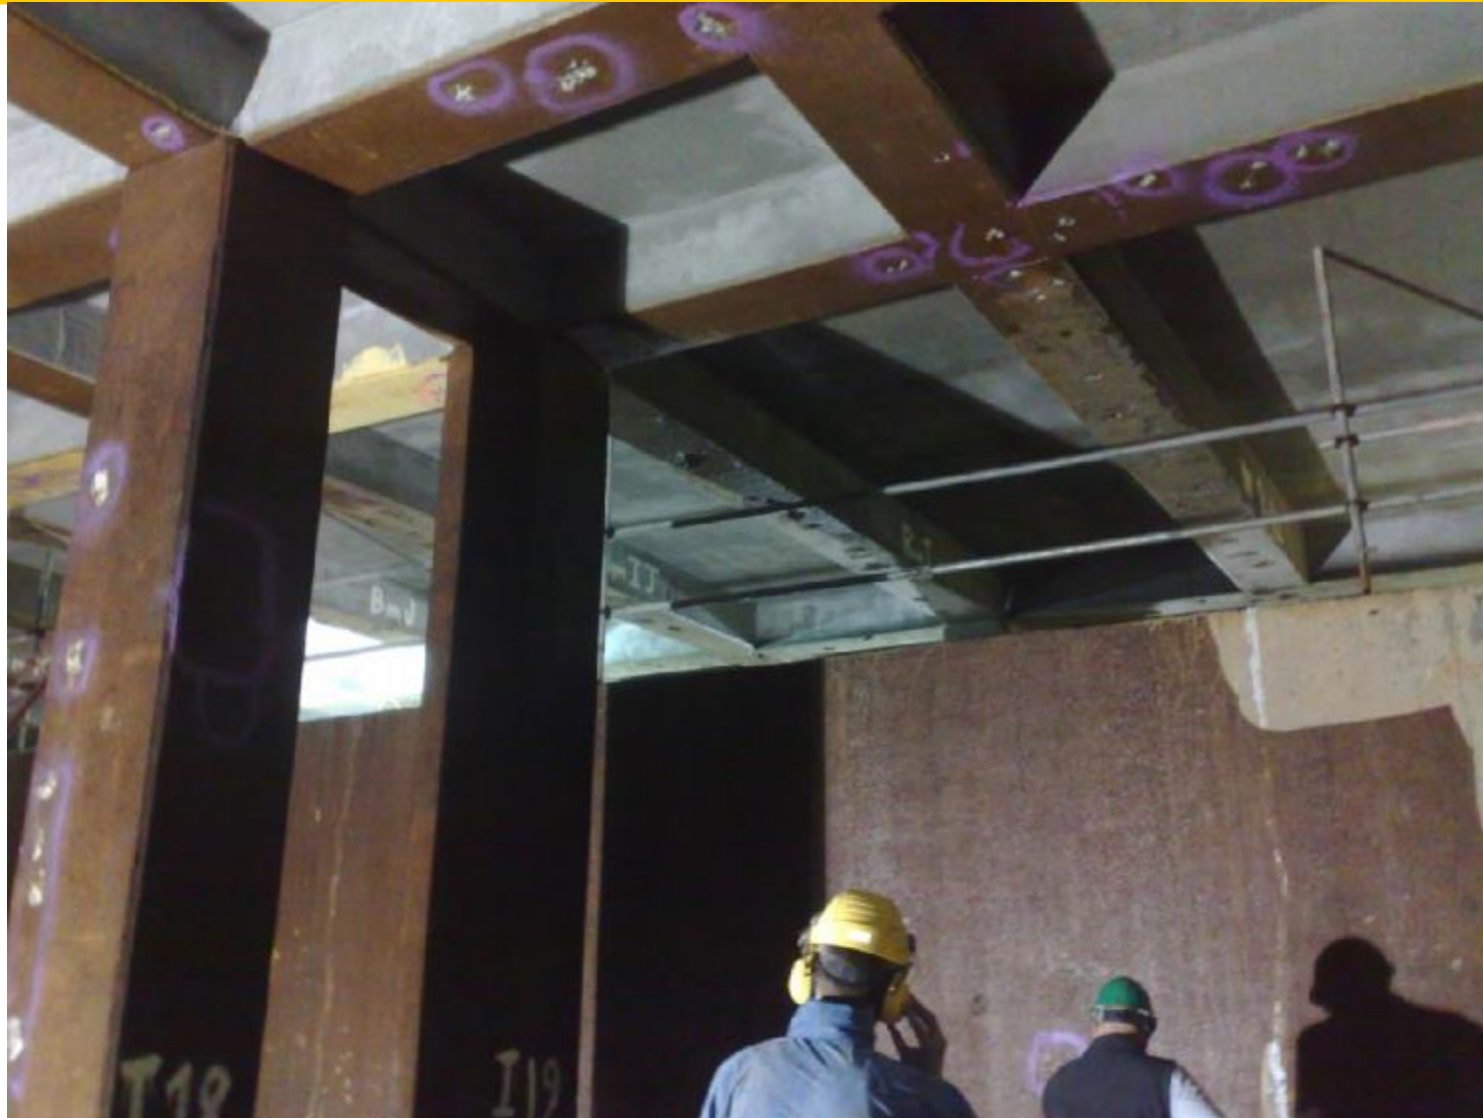
Marking

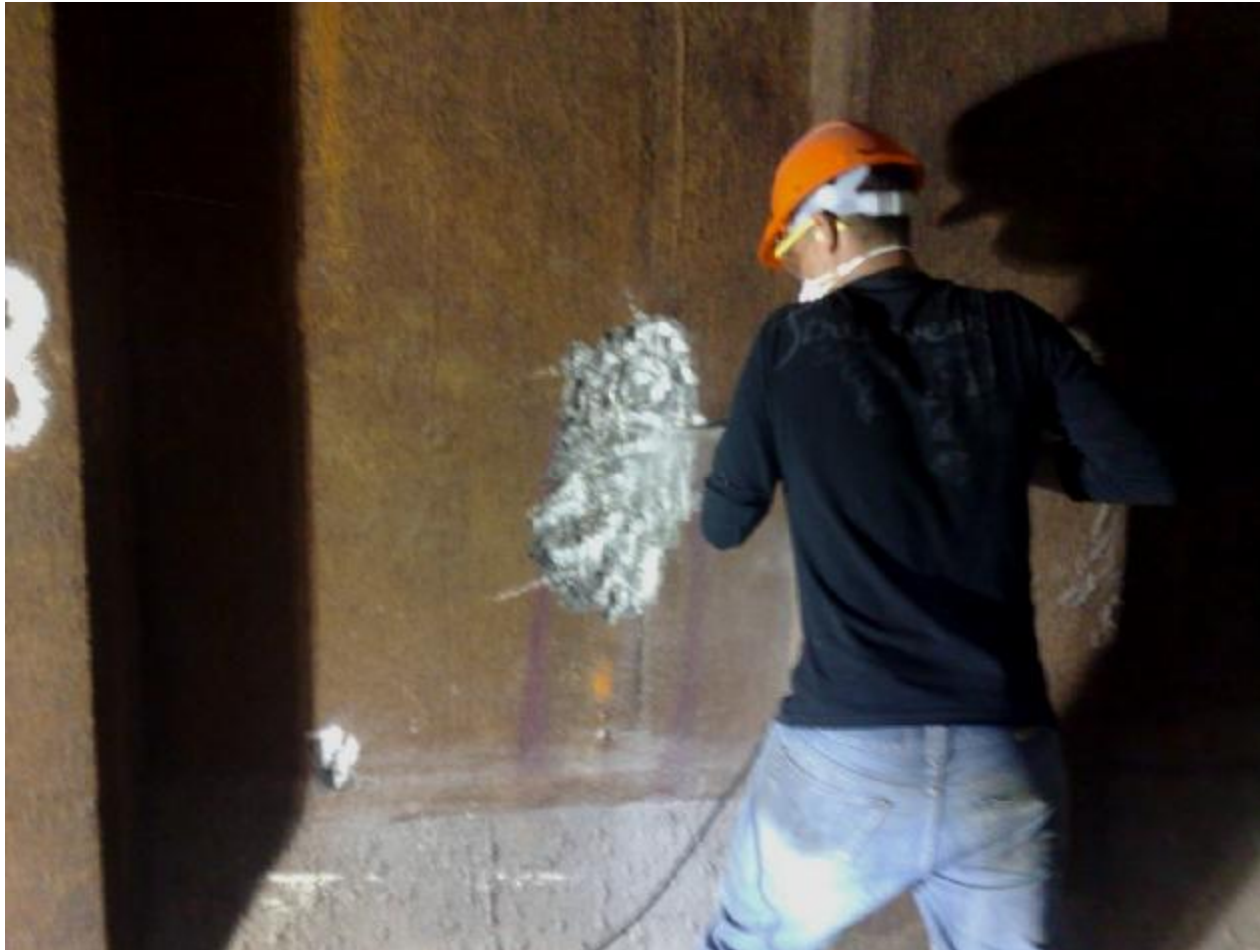
Getting to the rebars

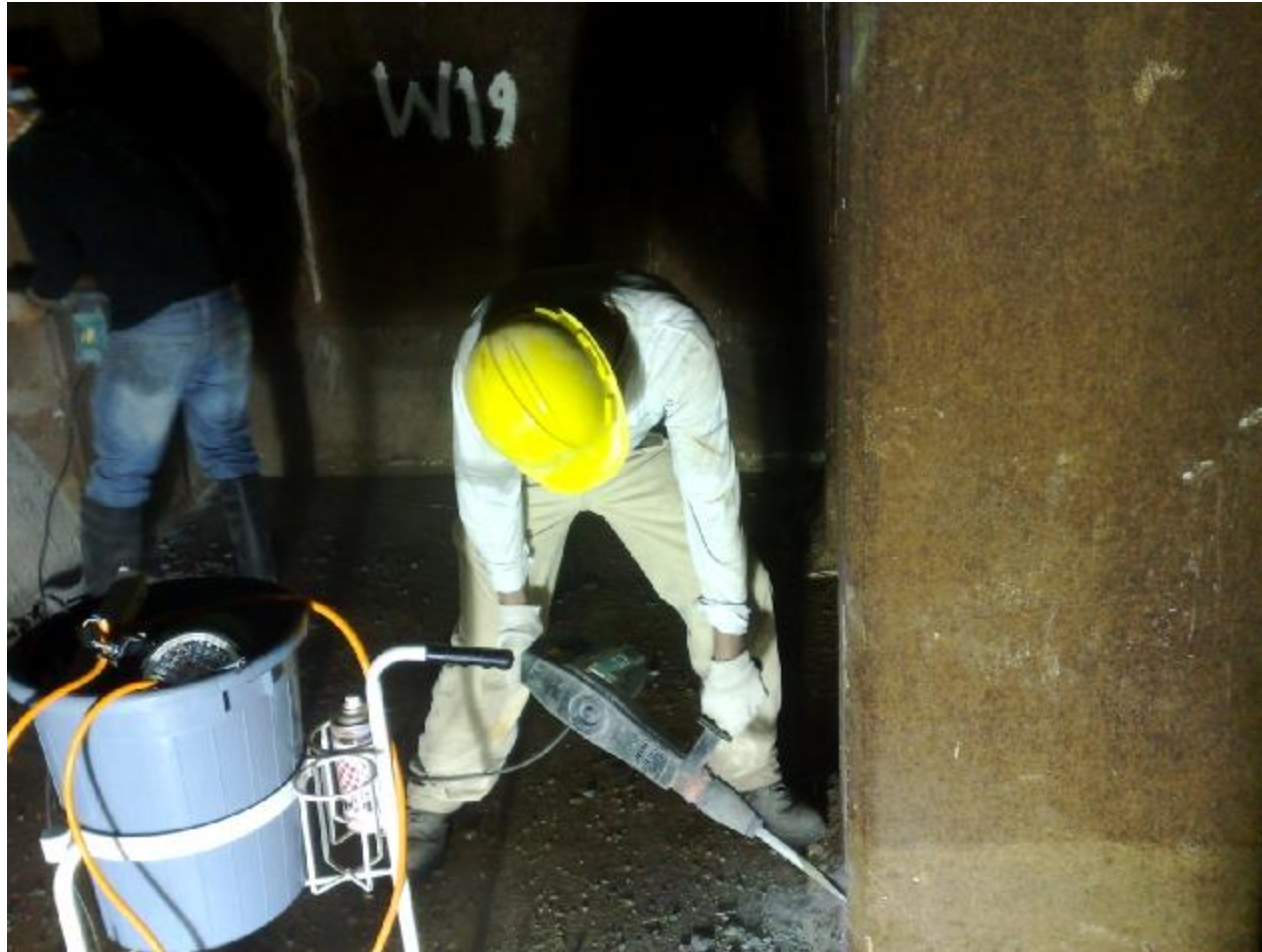
Expose the rebar

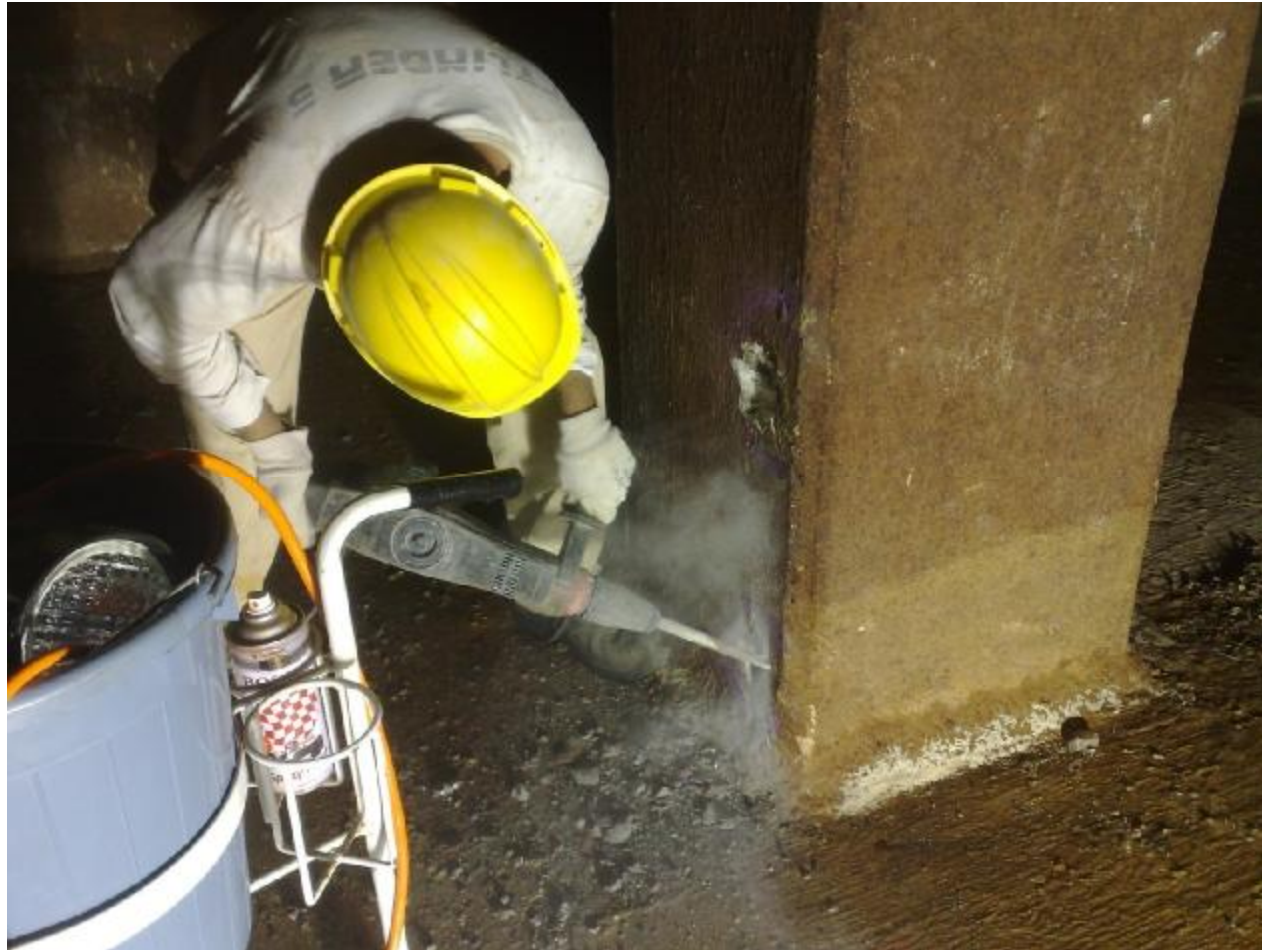
Using sika top 110

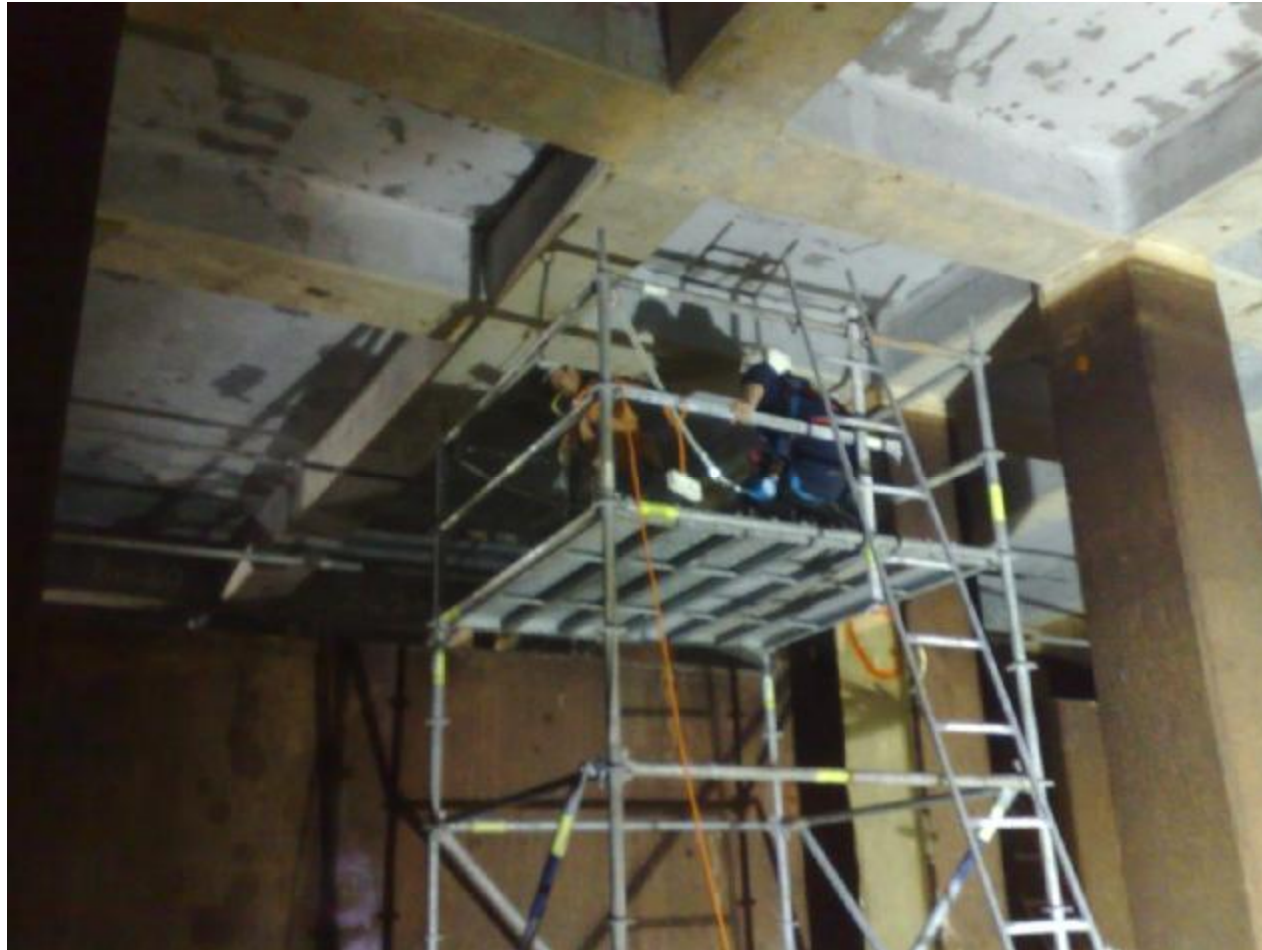
ceiling and beams treatment
