Job profile

- Project: rehabilitation of a desalination facility.
- Total area 12,000 sqm of pools and channels (in two parts)
- Location: Ashkelon- south of Israel (5 km from Gaza)
- Completed: April 2009
- Contractor: Sya-Group

Desanilation

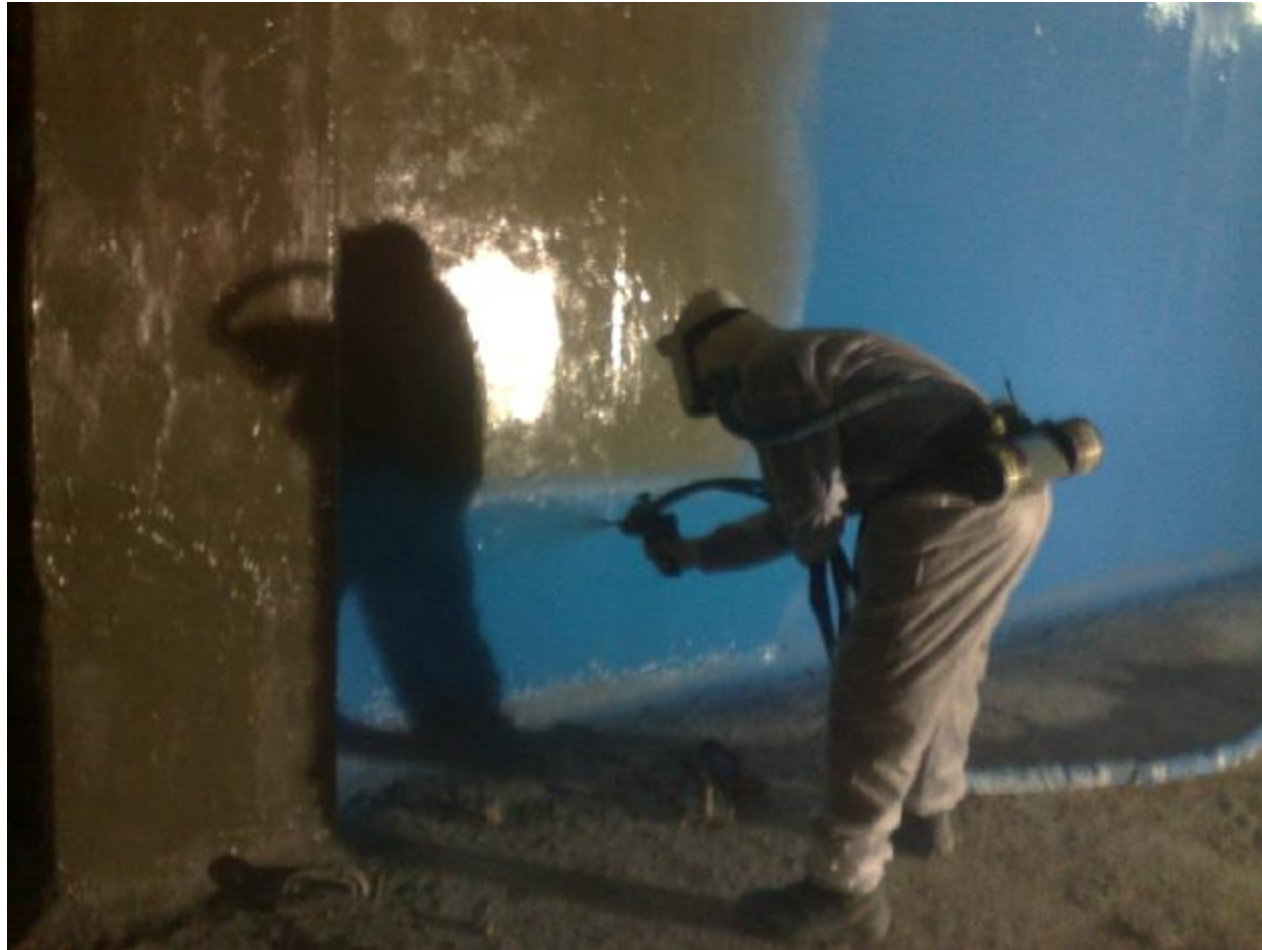
Spraying polyurea

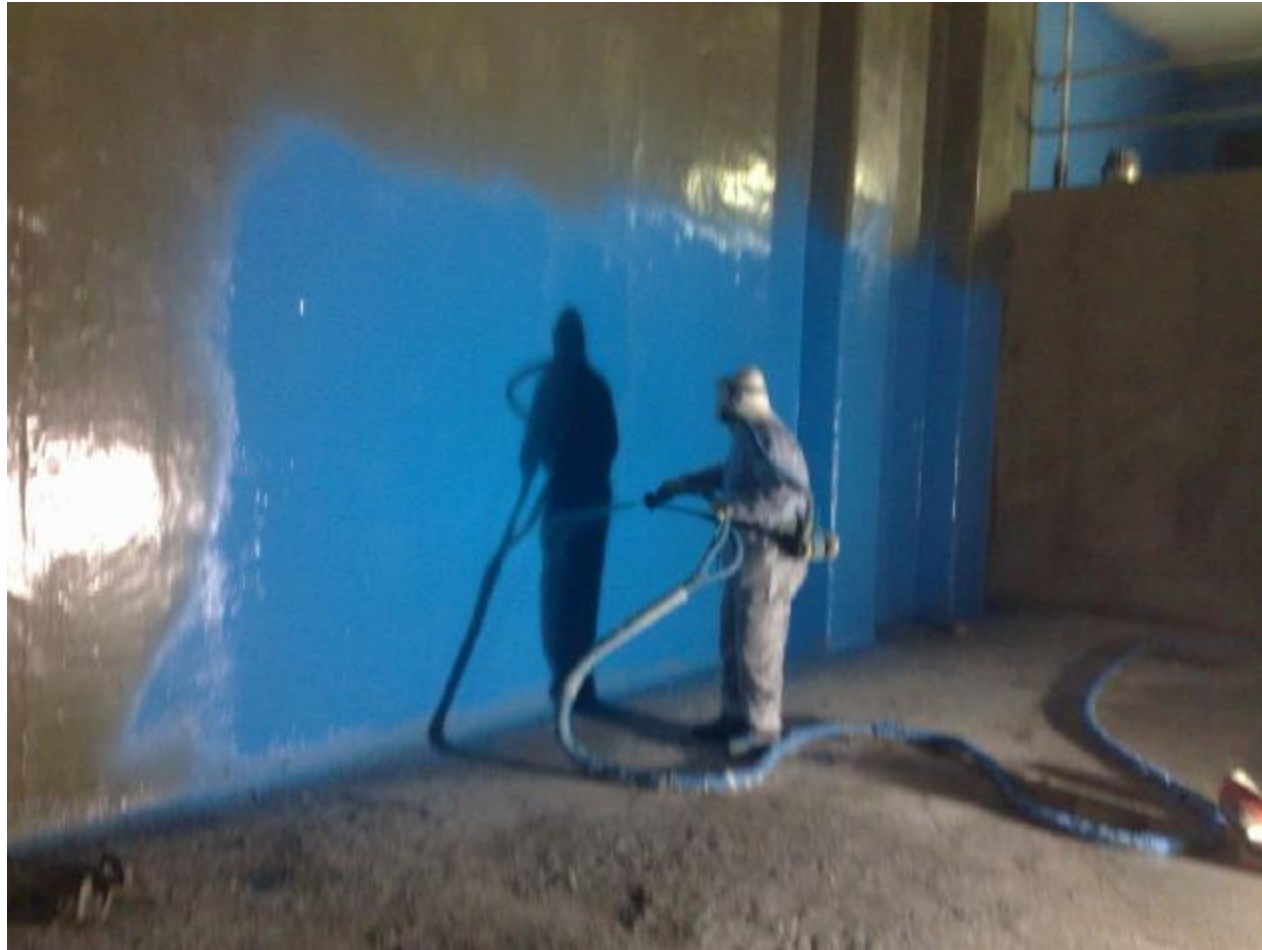
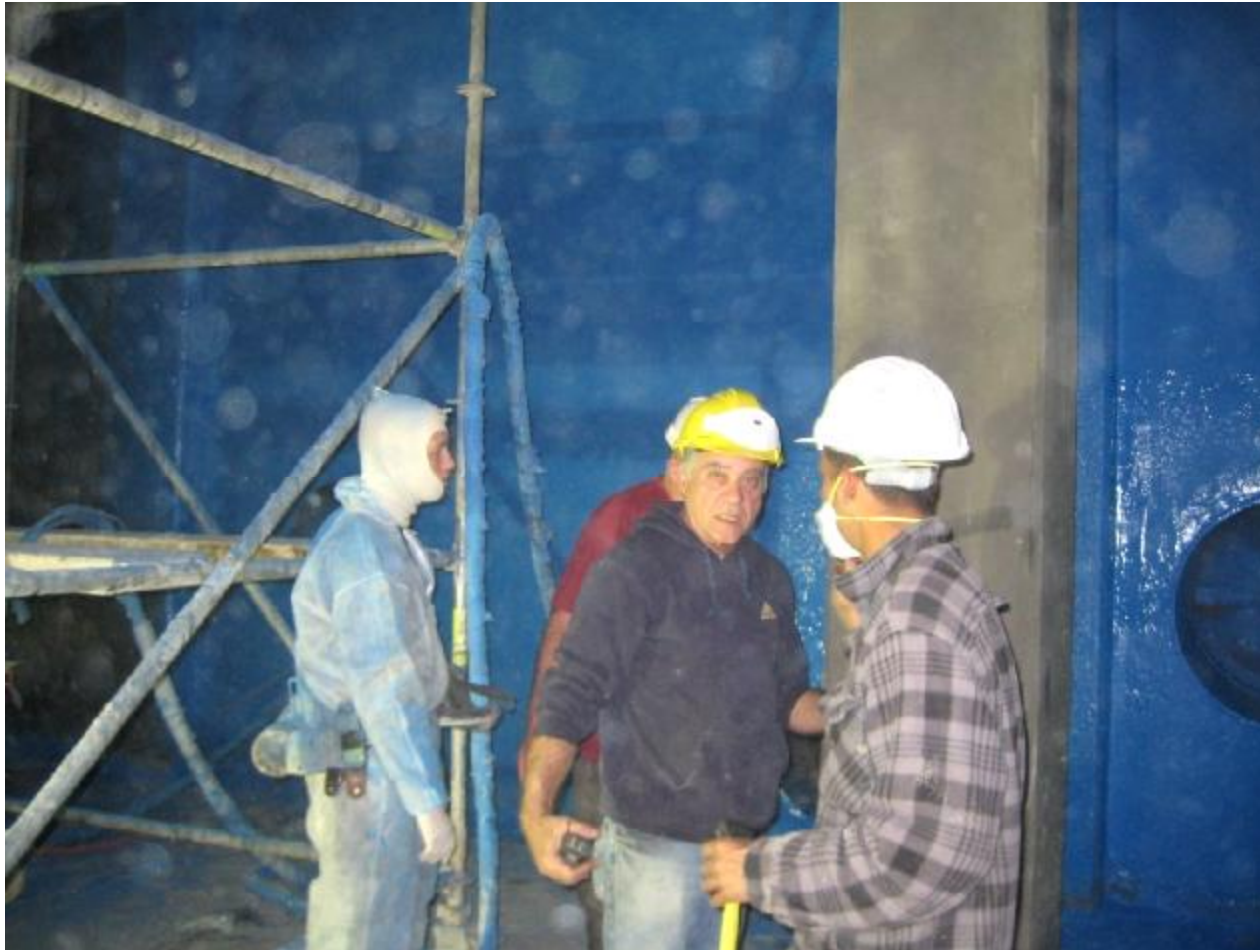
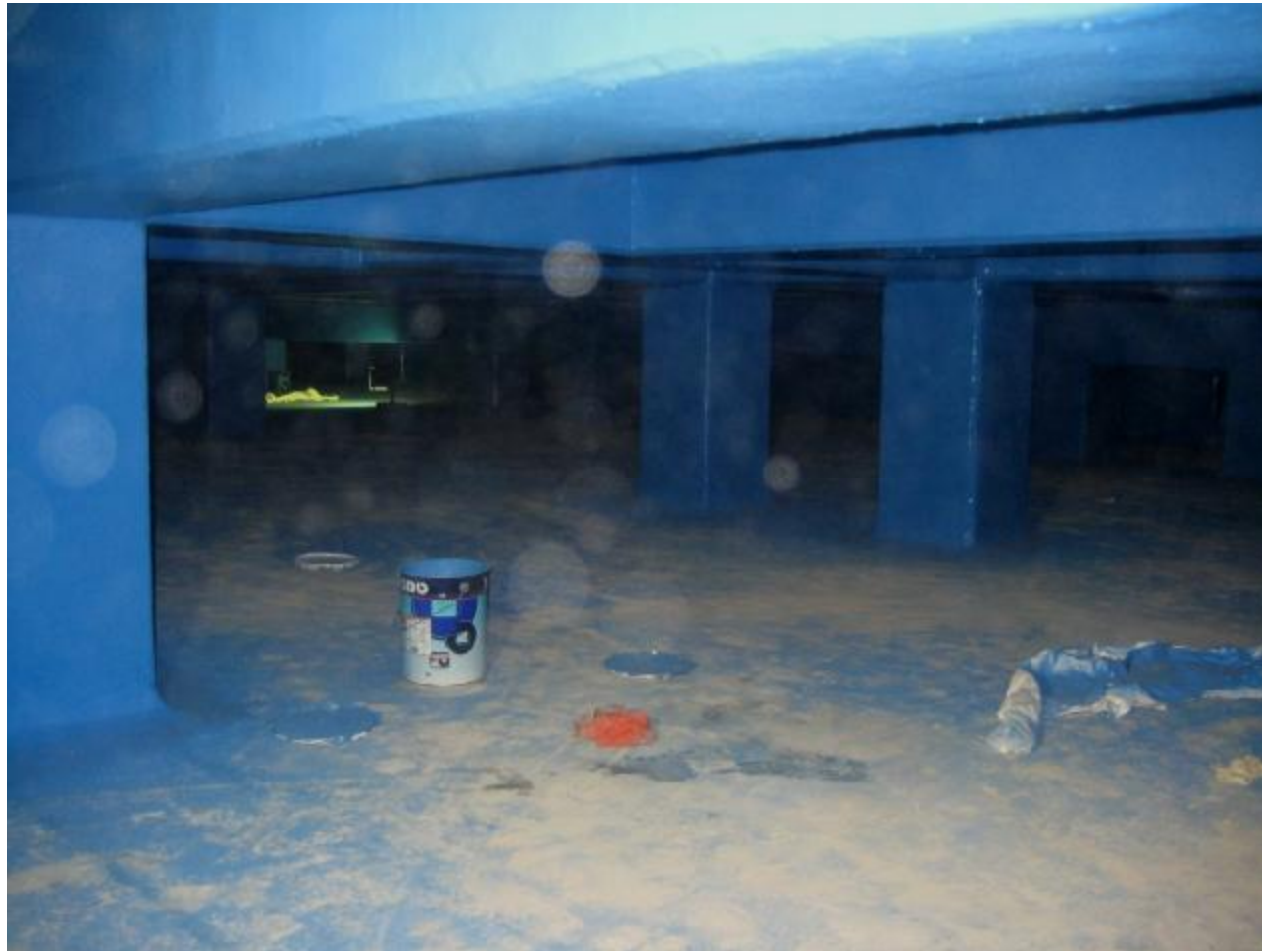
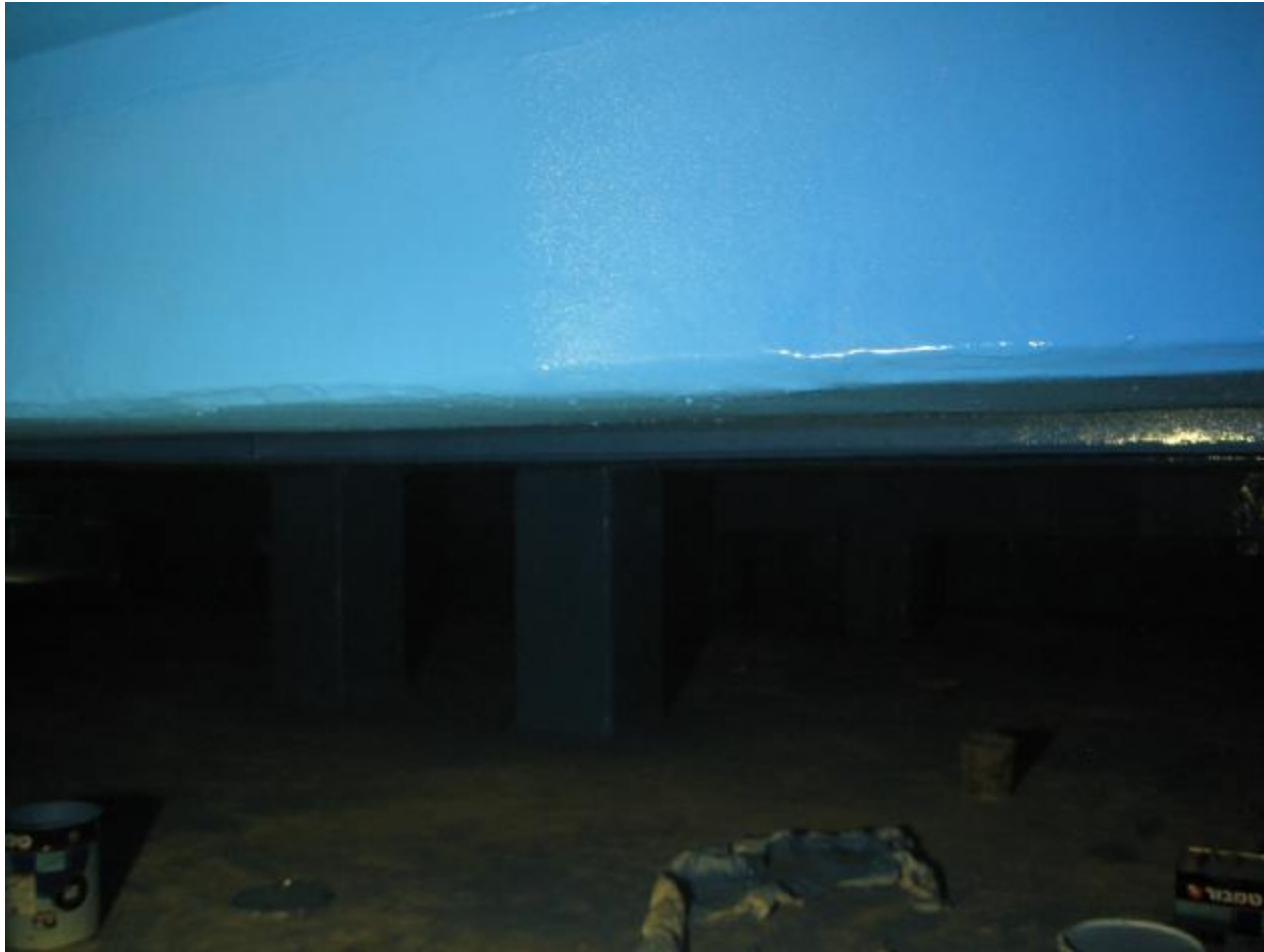
1500-2000 micron
